Shorebird nest fates at Boca Chica after rocket test launch

Prepared by Justin LeClaire, David Newstead
Coastal Bend Bays & Estuaries Program
June 6, 2024

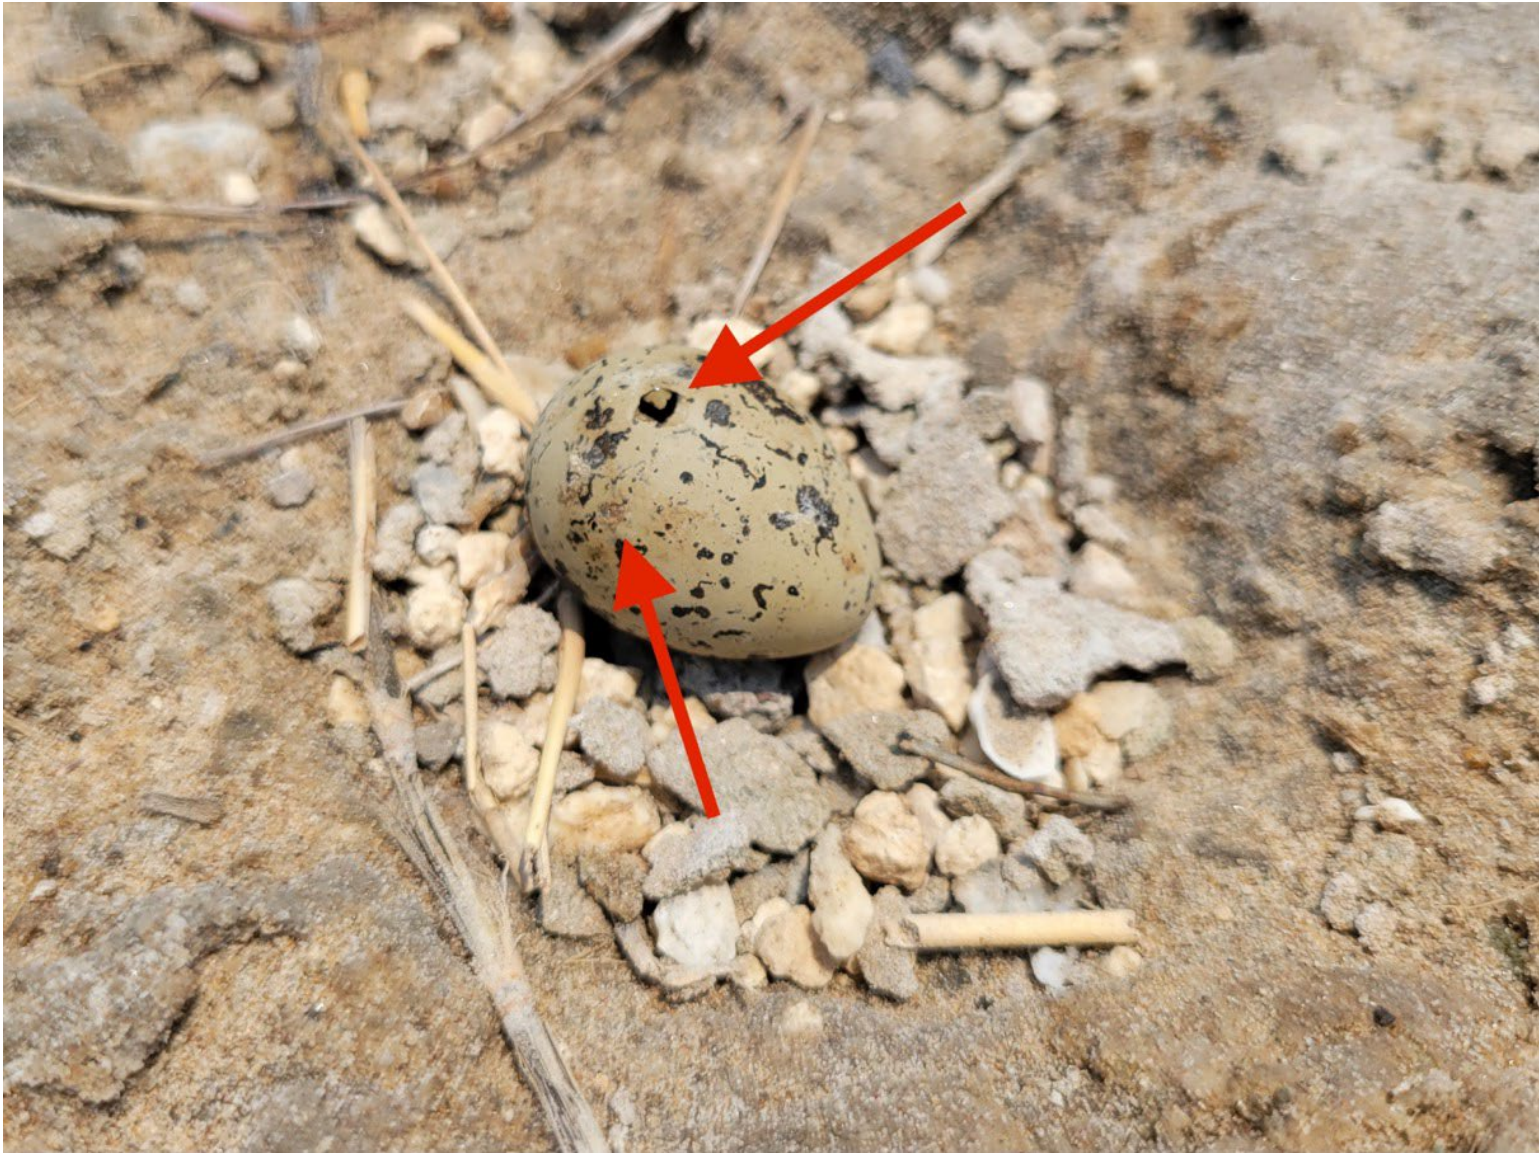
Cracks/holes in eggs ranged from relatively small cracks/notches up to fully penetrated pea-sized holes. Bloody egg contents were found on several egg exteriors near holes within them.

Figure 5. SNPL 2 close up photograph with arrows showing damage on single egg on June 6, 2024.

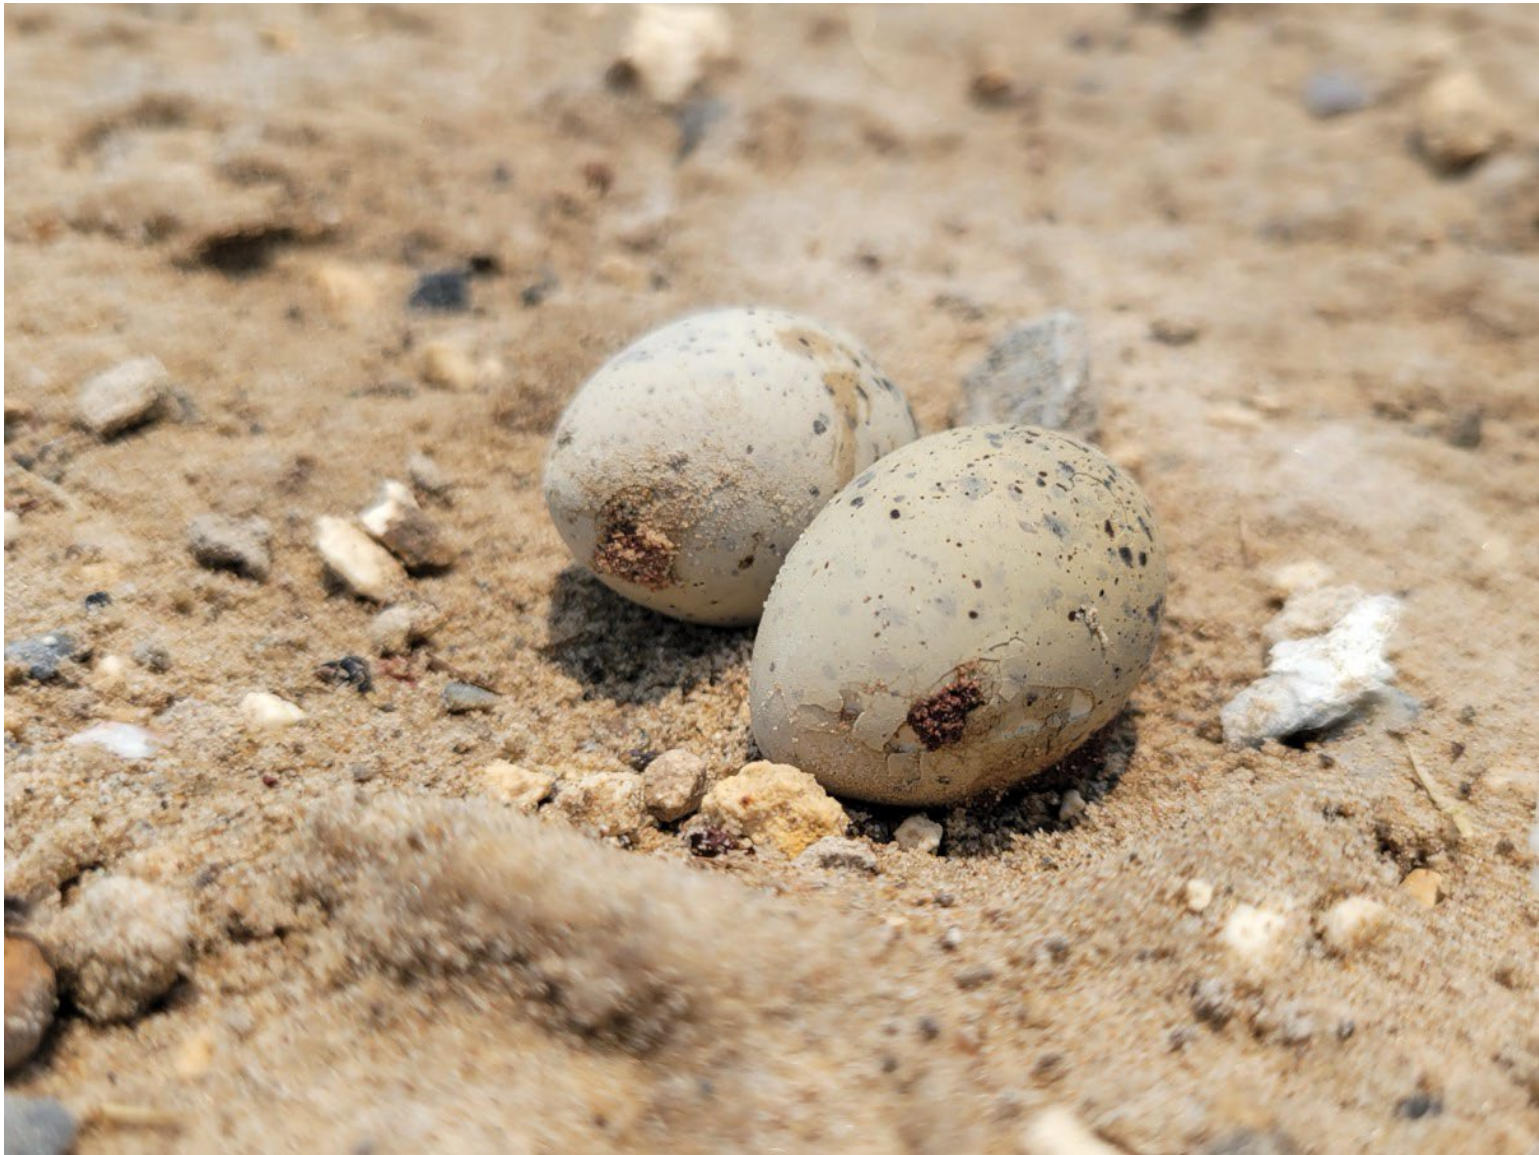
Figure 9. LETE 1 showing both eggs with large holes/cracks and dried egg contents emerging on June 6, 2024.
