## Oso Creek Bacteria Contamination Investigation

Publication CBBEP – 61  
Project Number – 0816  
July 2009

## FINAL SUMMARY REPORT

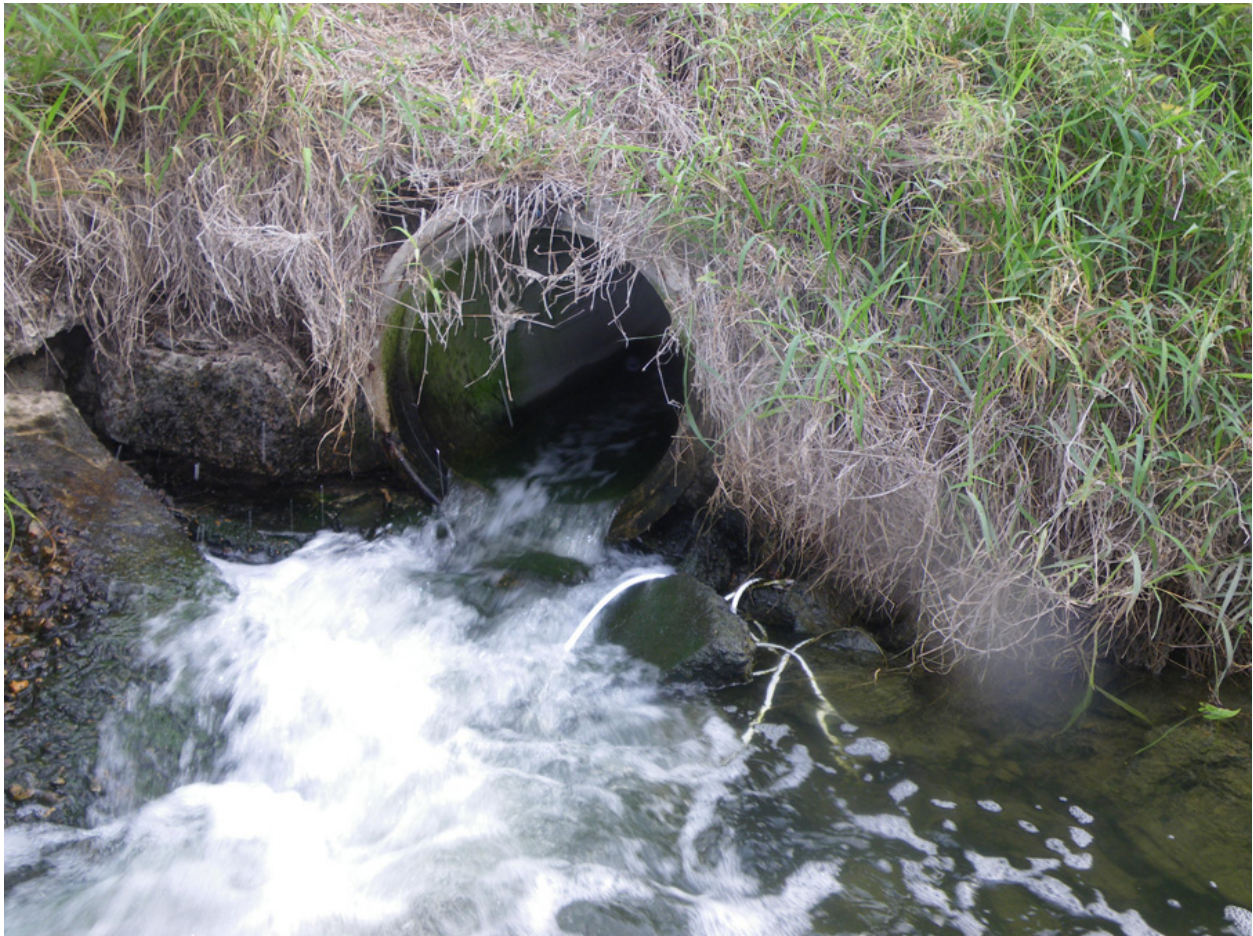
**Figure 6. Photo of OCB003 outflow.**

OCB003 is located in Robstown at the discharge for the Robstown Wastewater Treatment Plant.

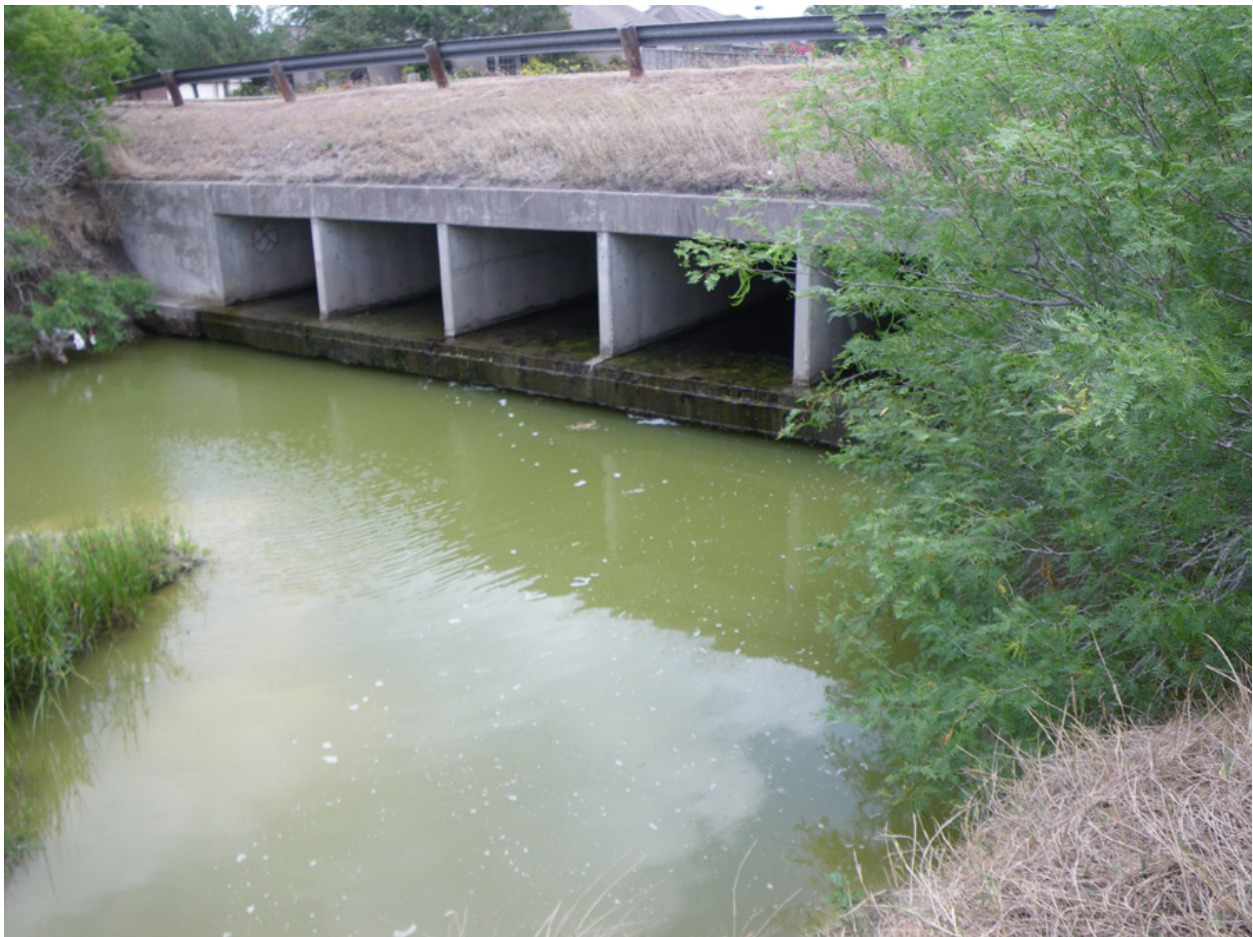
**Figure 8. Photo of OCB041 Outflow.**

OCB041 is located on Oso Parkway between Odessa Dr and Cisco Circle. This is a large ditch running through the neighborhood that intersects with Oso Creek about 1.5 km upstream from Staples St.

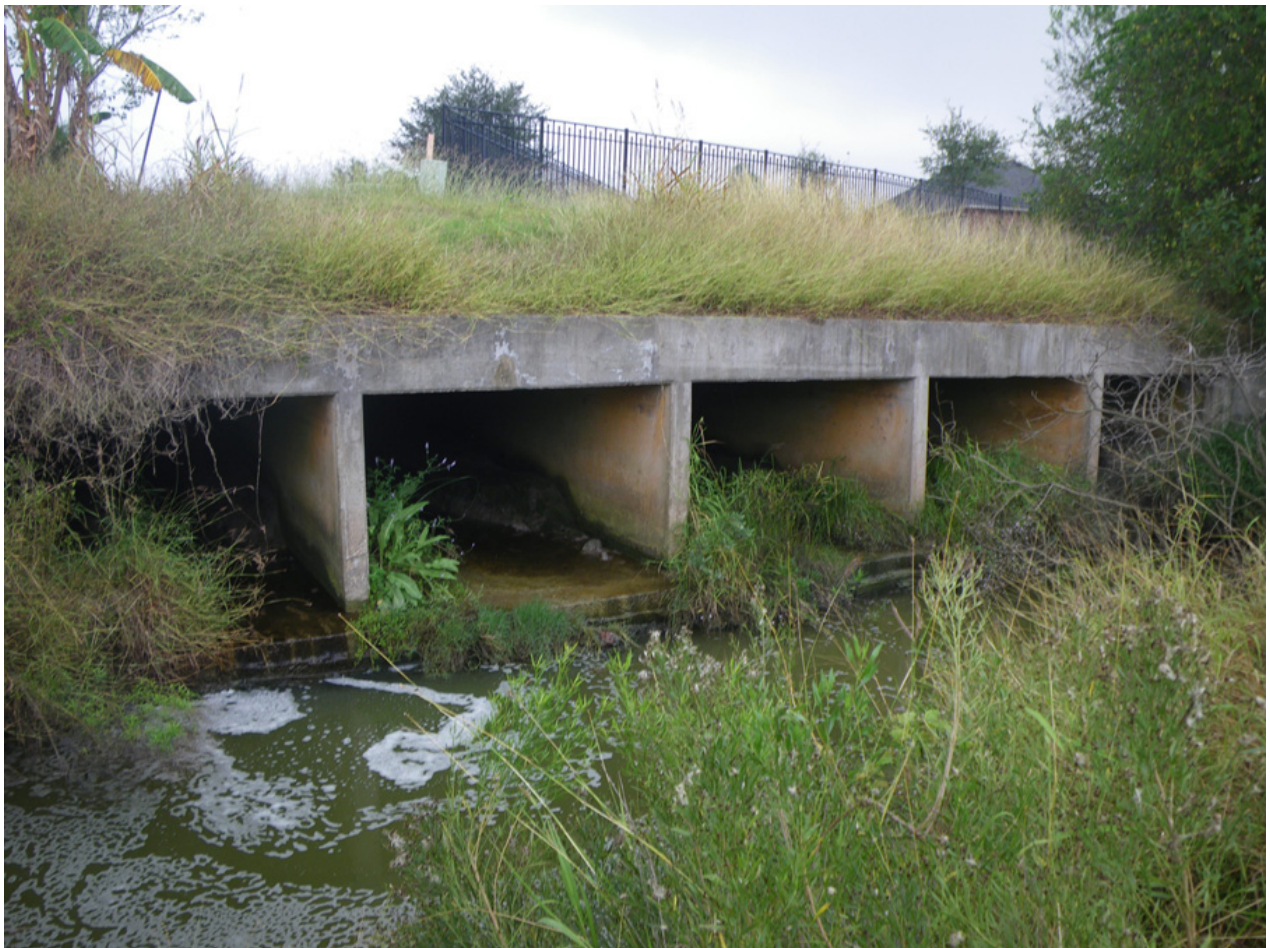
**Figure 10. Photo of OCB038.**

OCB038 is located in the King's Crossing neighborhood off Staples St, and is found behind the houses on Valtourmanche Dr. The drains empty into a small ditch that flows towards the Oso Creek.

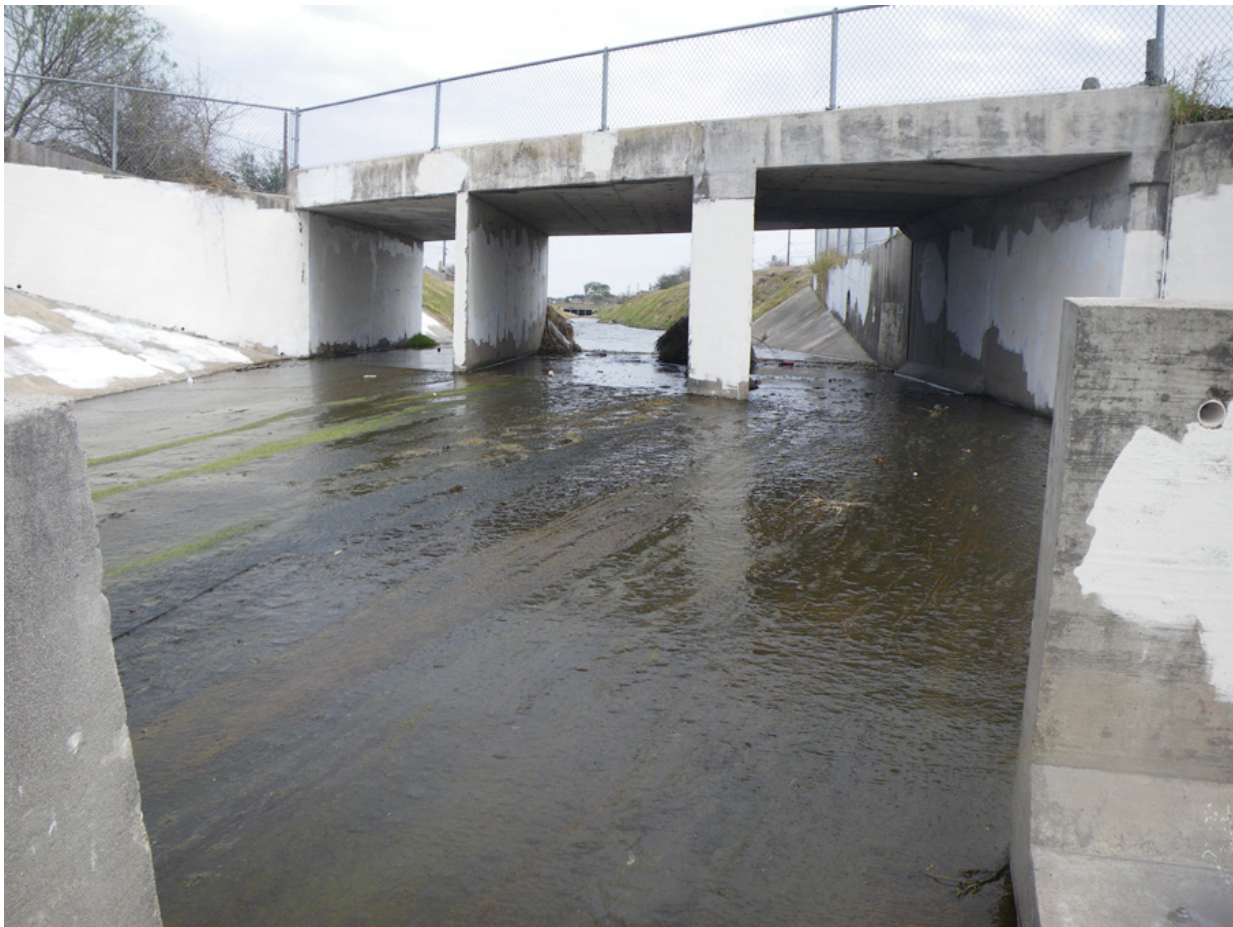
**Figure 12. Photo of OCB048 Outflow.**

OCB048 is located at Sun Valley Dr near the intersection of Yorktown Blvd and Weber Rd. This is a large ditch running through the neighborhood, starting above Saratoga Blvd.

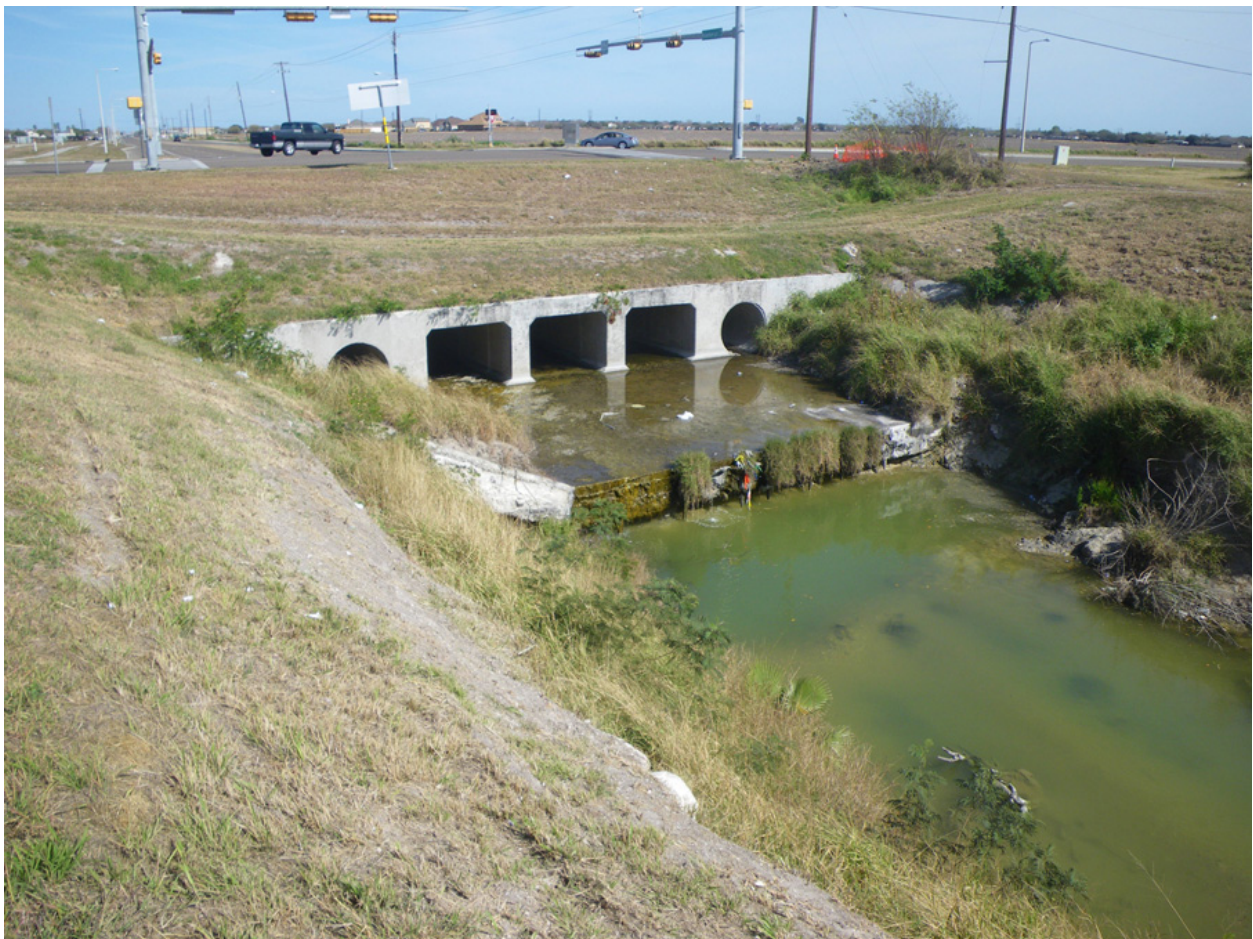
**Figure 14. Photo of OCB051.**

OCB051 is located at the Kostoryz Rd and Saratoga Blvd intersection. There are several openings that flow out from under Kostoryz Rd. They flow over a cement slab then empty into a large ditch that flows out to the Oso Creek.

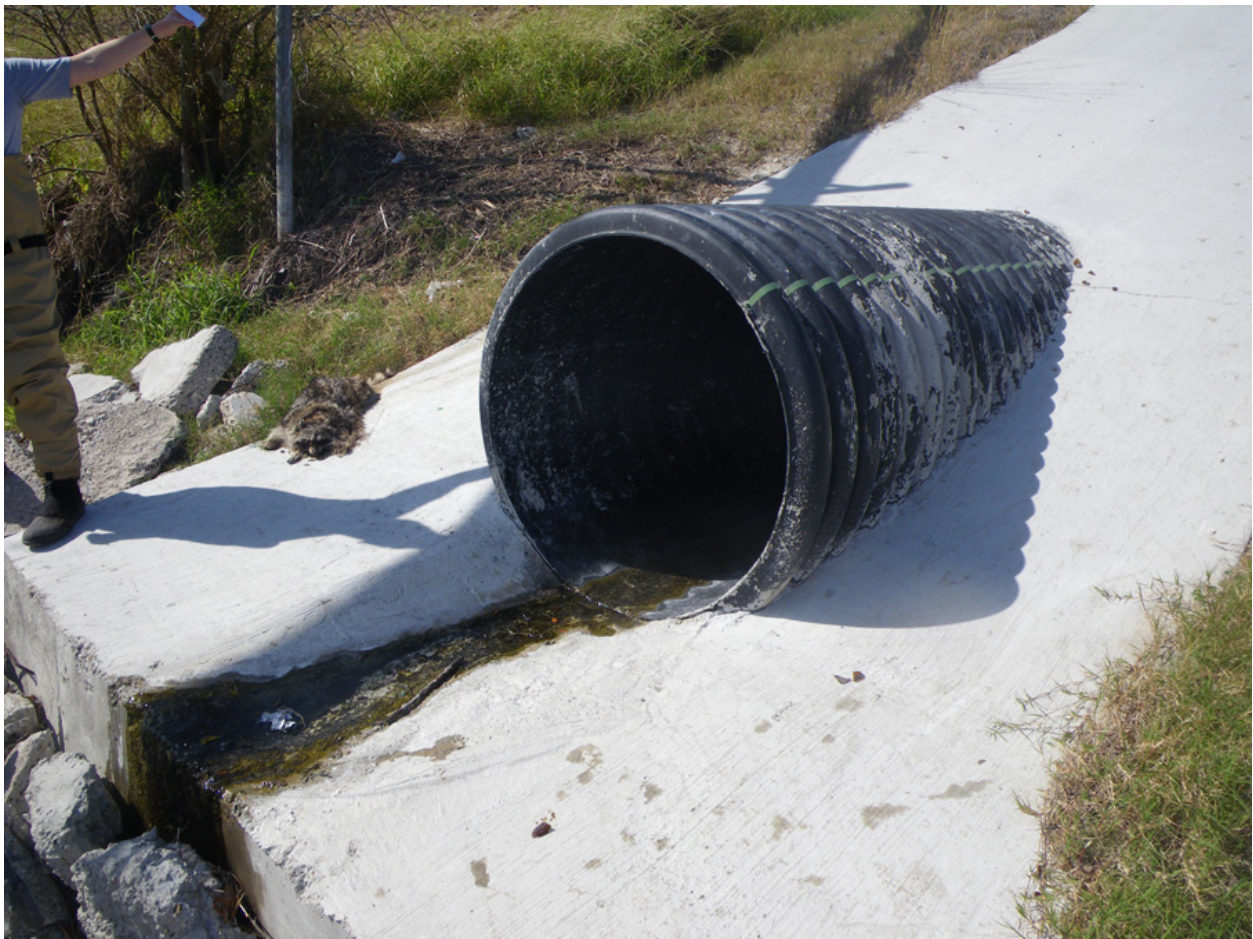
**Figure 16. Photo of OCB050 Outflow.**

OCB050 is located at near OCB051 off of Cabaniss Pkwy. This is a large plastic pipe that flows into the same ditch as OCB051. The pipe is just behind the Cabaniss Field parking lot.

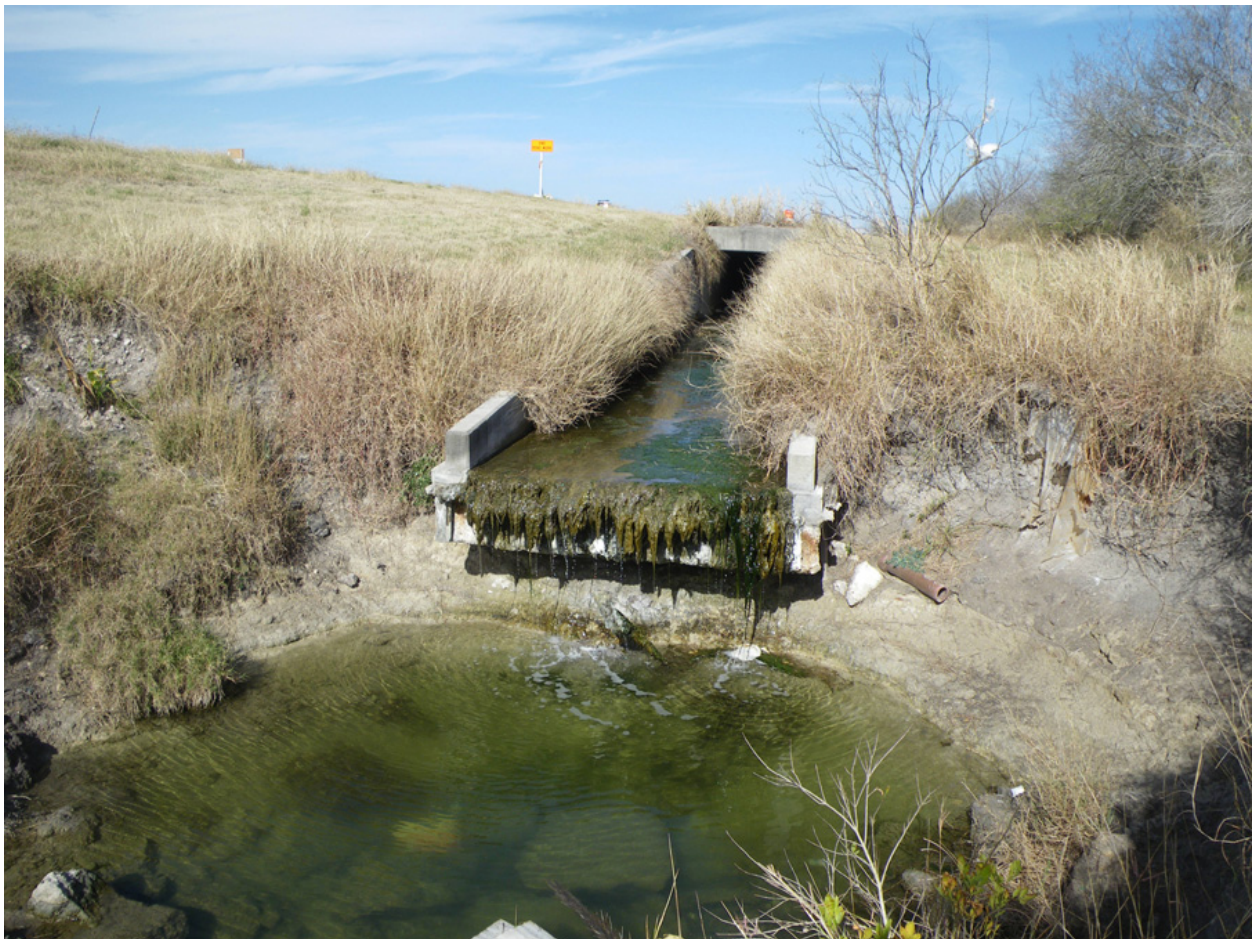
**Figure 18. Photo of OCB054.**

OCB054 is located where TX-286 crosses over the Oso Creek. There is a cement drain that empties into a ditch that leads to the Oso Creek.

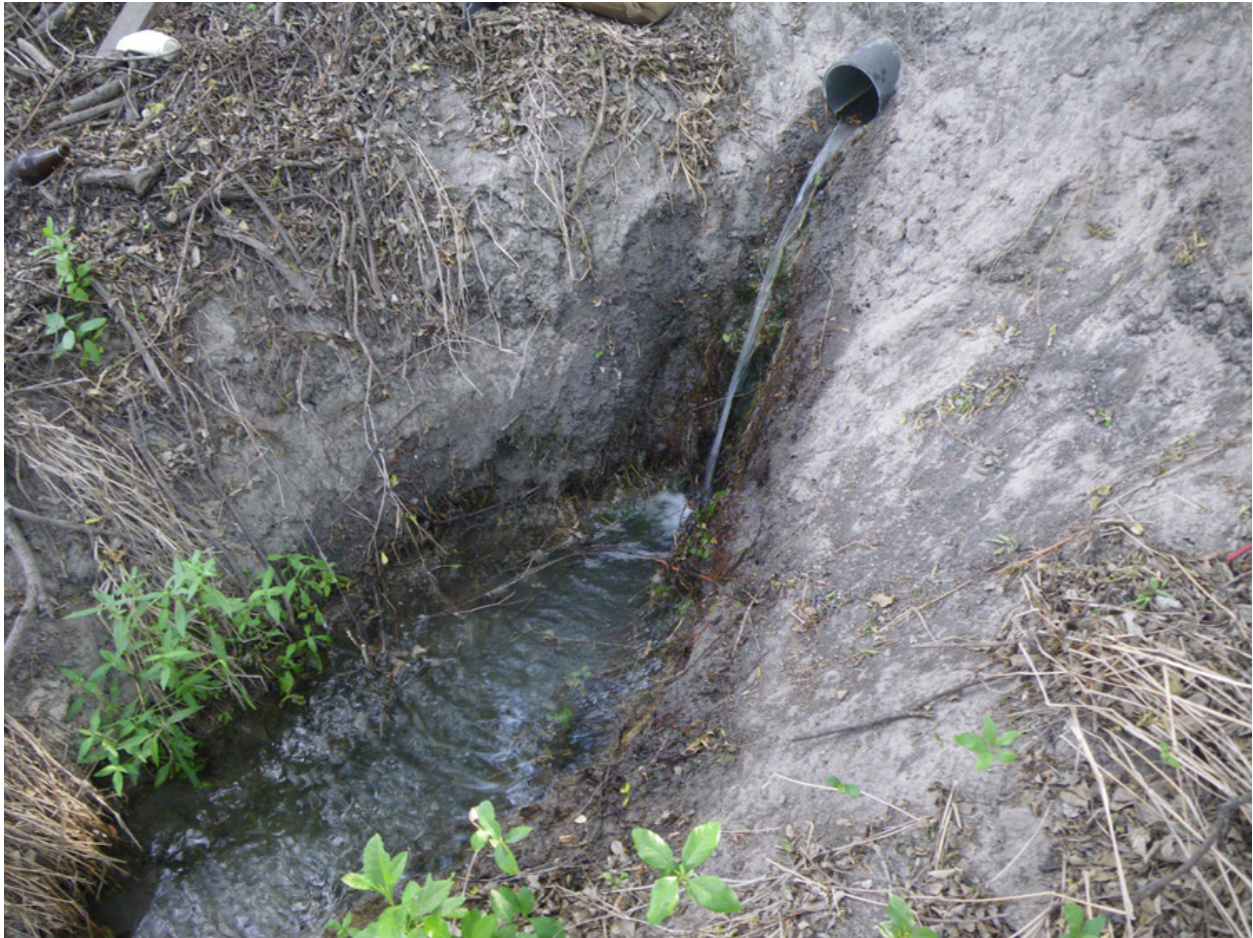
**Figure 20. Photo of OCB063.**

OCB063 is located just downstream from Old Brownsville Rd. This is a small plastic pipe coming from the People's Baptist Church WWTP. The water from this pipe flows down a small embankment into Oso Creek.

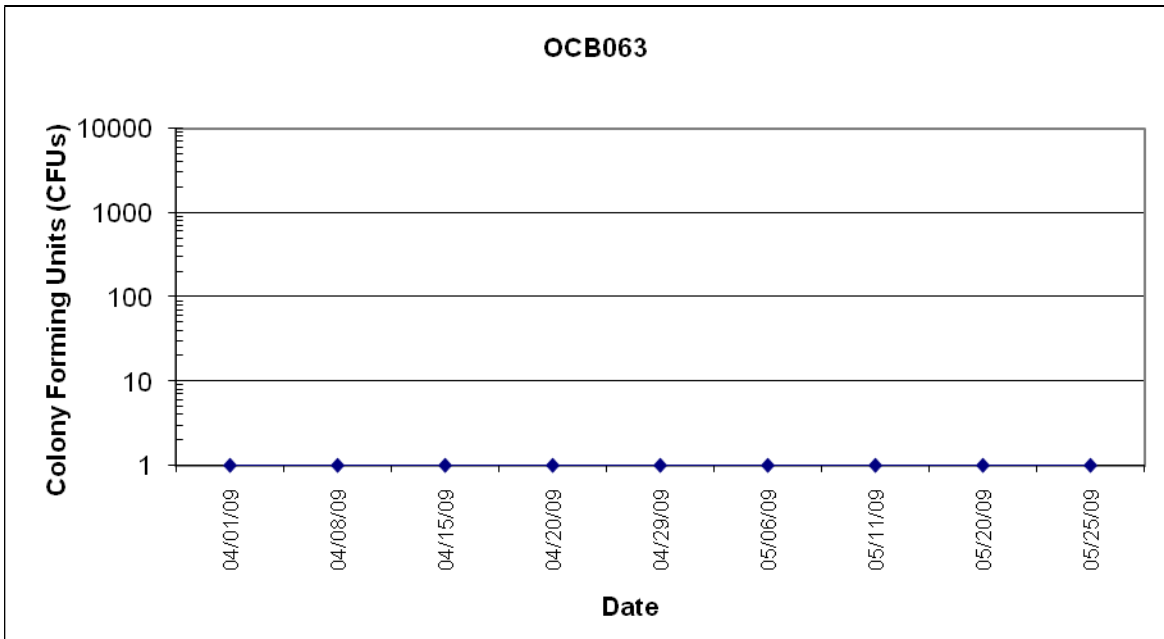
*Enterococcus* levels at this site were extremely low and ranged from <1 to 1 cfu/100mL throughout the sampling events. Mean and median were 1 cfu/100mL, and mode was <1 cfu/100mL.

**Figure 21. Summary of Bacteriological Data for OCB063.**

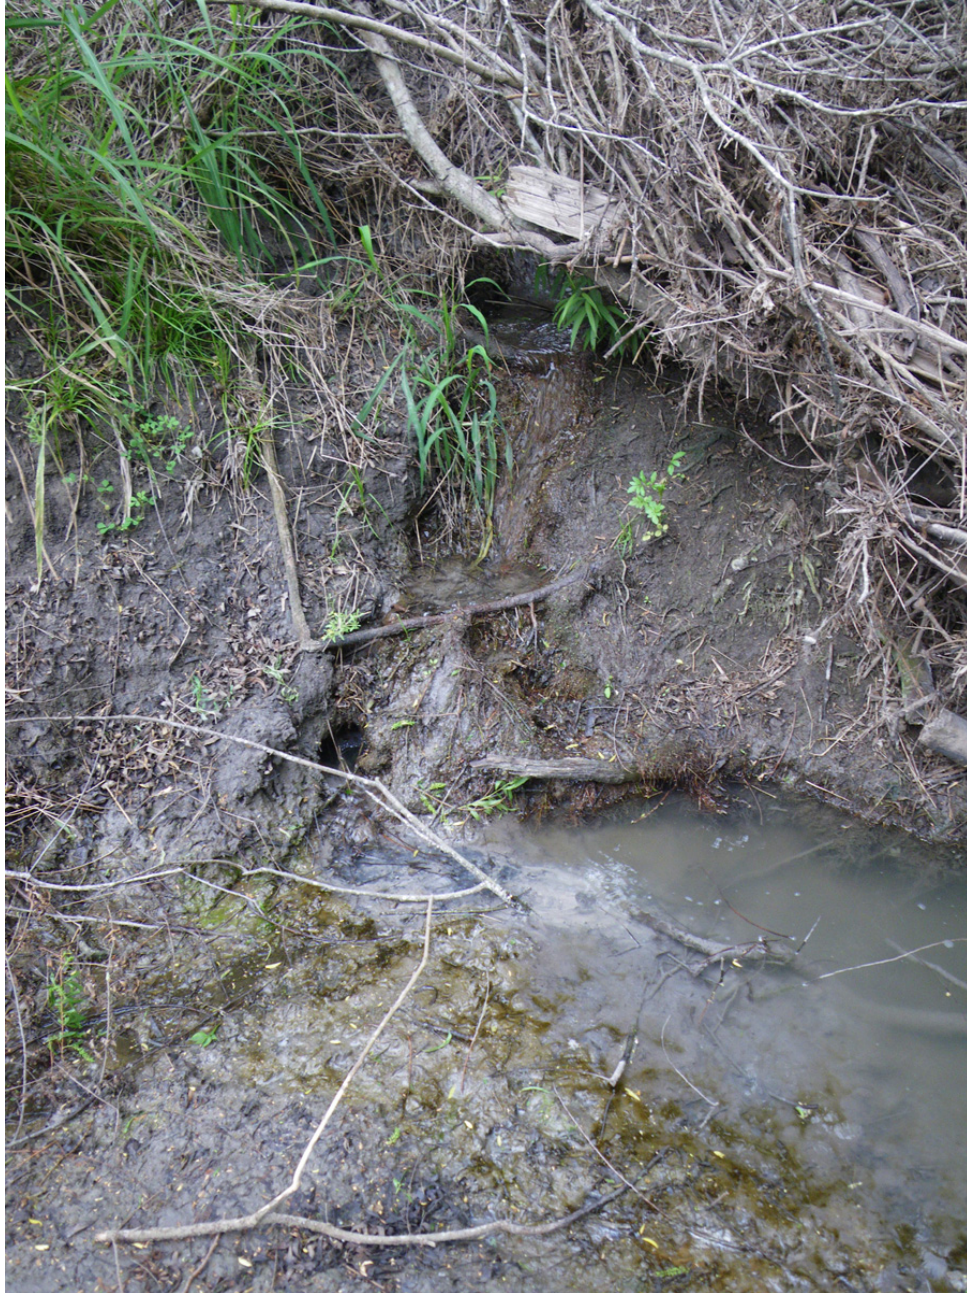
Figure 22. Photo of OCB065.

OCB065 is located 1.7 km upstream from FM-763. It is a pipe from the Cuddihy WWTP on the same land as OCB063, which is owned by the People's Baptist Church. A pool of water forms over the pipe and gradually flows down a small path towards Oso Creek.

*Enterococcus* levels at this site ranged from <1 to 240 cfu/100mL. The average level was 40 cfu/100mL, with a median of 4 cfu/100mL and a mode of <1 cfu/100mL.

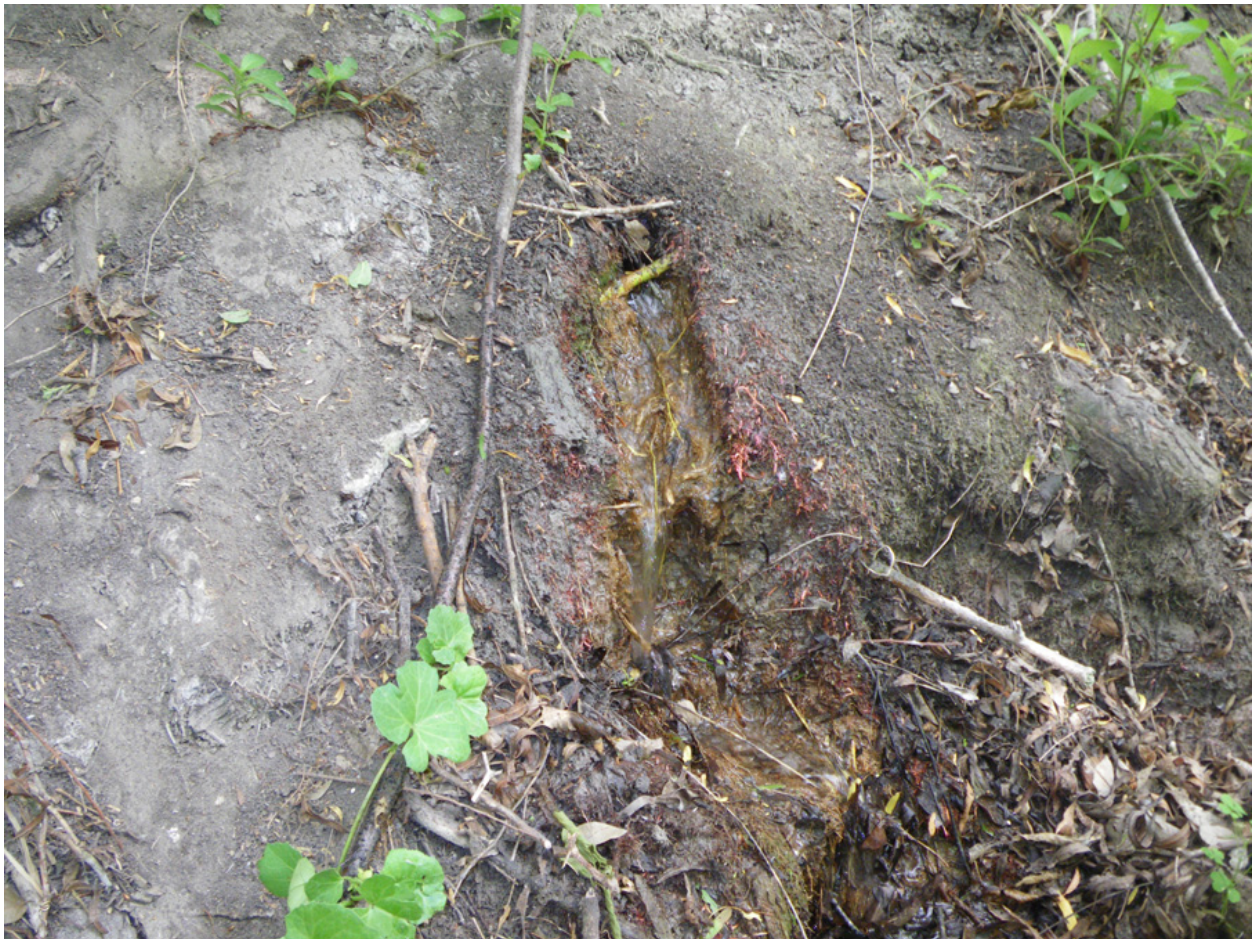
Figure 24. Photo of OCB064.

OCB064 is located just upstream from FM-763. There is no apparent pipe, but instead water appears coming out of a hole in the ground. The water flows down the bank of the creek directly into the Oso Creek.

Not a single *Enterococcus* colony was isolated from the nine sampling events at this location. All levels were reported as <1 cfu/100mL, our minimum detectable limit.

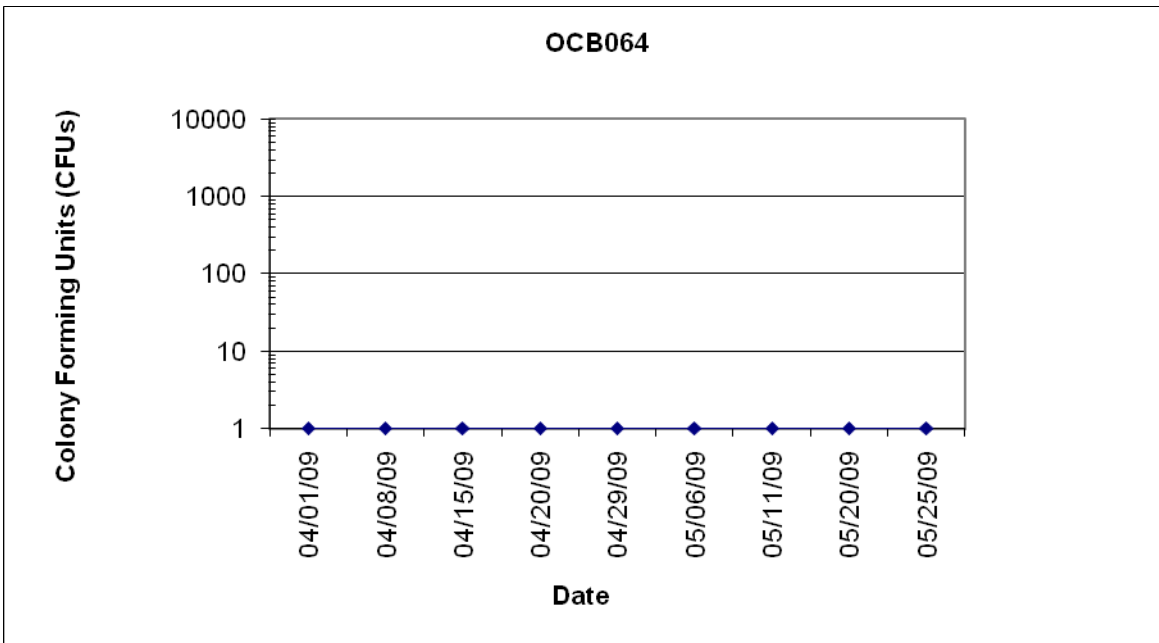
**Figure 25. Summary of Bacteriological Data for OCB064.**

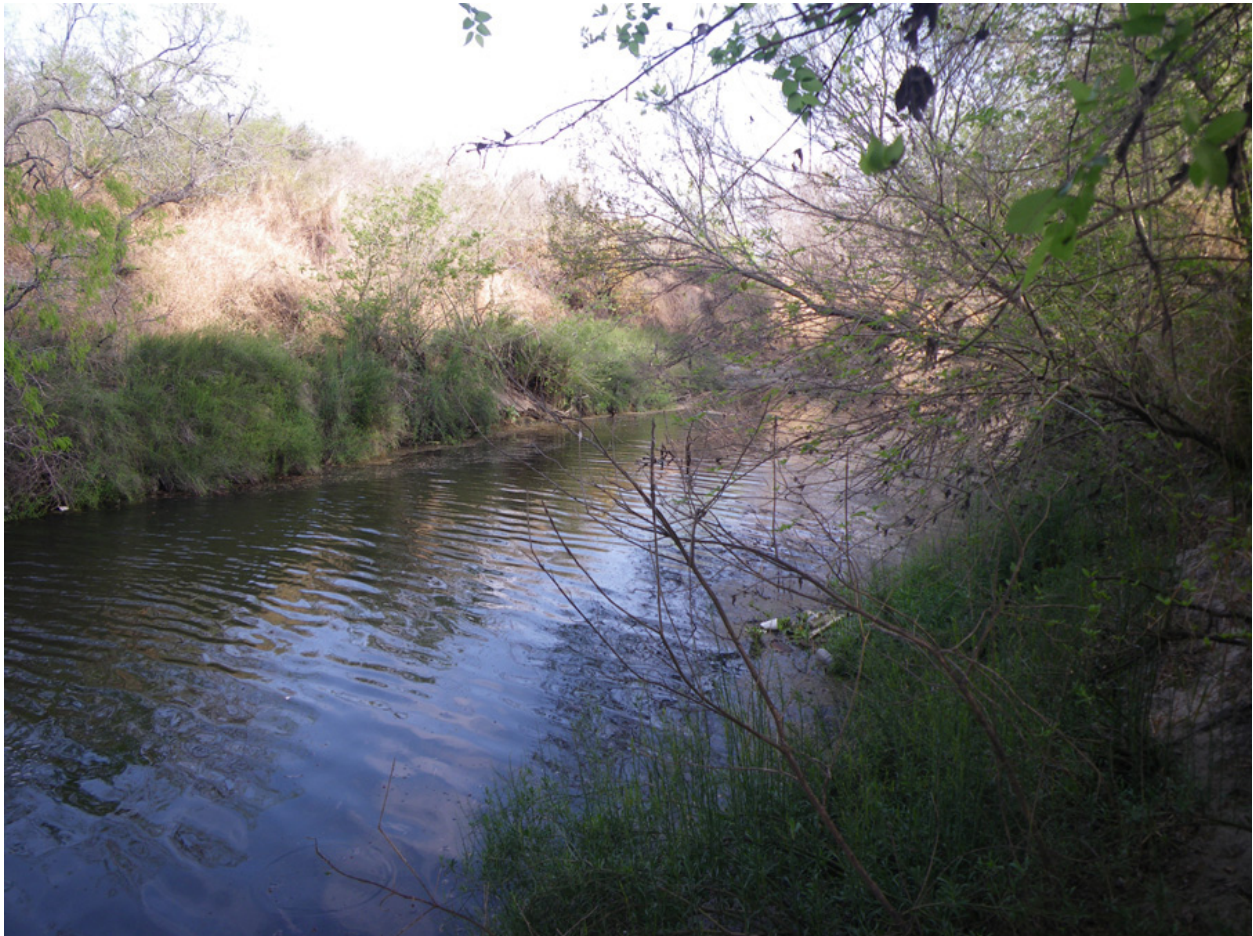
Figure 26. Photo of OCB062.

OCB062 is located inside the Corpus Christi landfill off TX-286. The sampling site is 370m NW of the locked gate at the end of the main road in the landfill. It is a large creek that flows from the Cabaniss airport area and passes under Saratoga at Greenwood. The Greenwood WWTP also discharges into this creek. Thus the site is a combination of runoff and outflow from the WWTP. This creek empties into Oso Creek 2.4 km upstream from TX-286.

The *Enterococcus* levels at this site ranged from 35 to 270 cfu/100mL. The mean level was 137 cfu/100mL, with a median of 117 cfu/100mL. Mode for this site is not applicable, as no values were repeated.

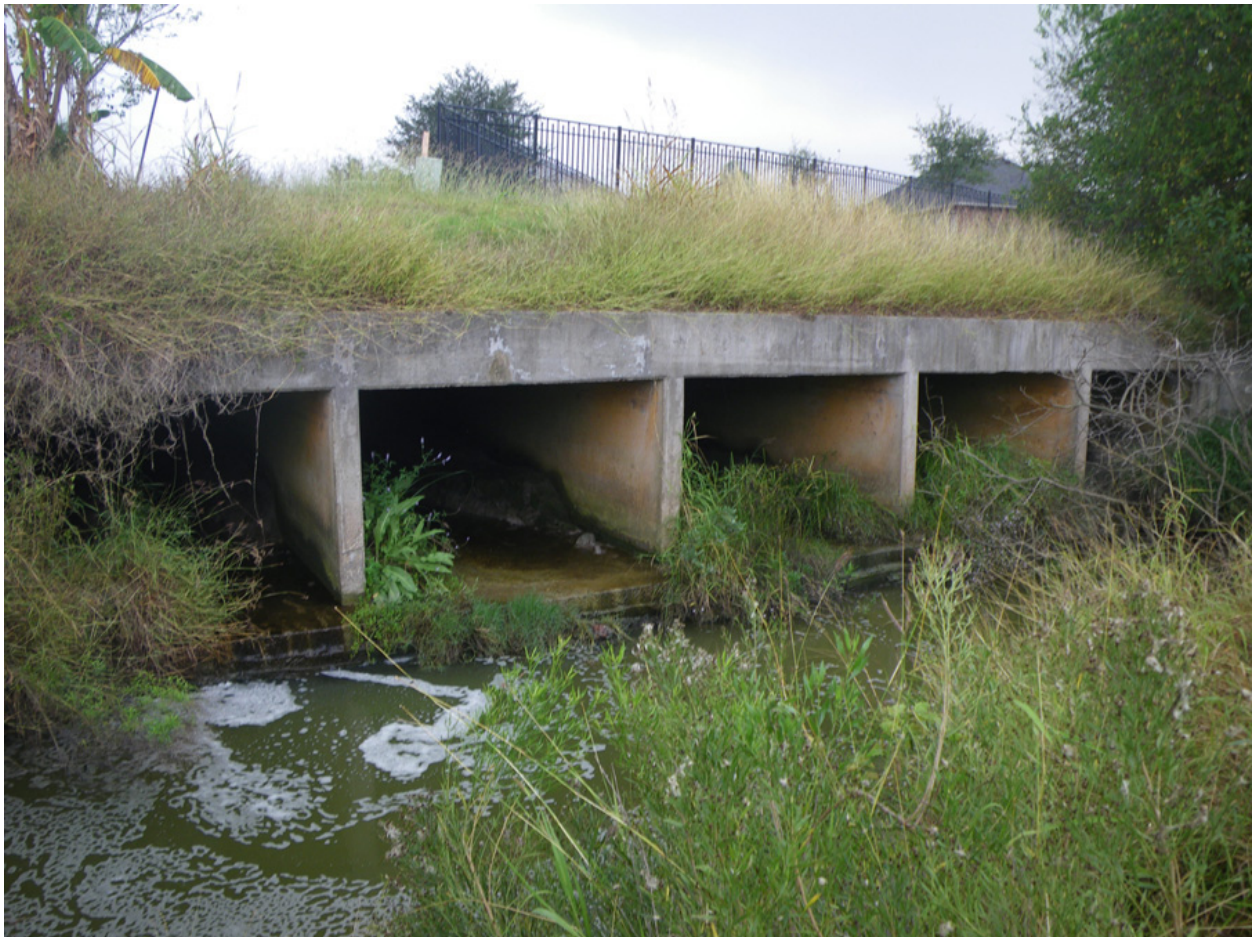
Figure 28. Photo of OCB067.

OCB067 is at the same location as OCB038, in the King's Crossing neighborhood off Staples St, and is found behind the houses on Valtourmanche Dr., however a separate flow on the south end of the drainage was noted on 4/15/2009 and sampled as a separate site. The water drains empty into a small ditch that flows towards Oso Creek. *Enterococcus* levels at this site ranged from 68 to 680 cfu/100mL.

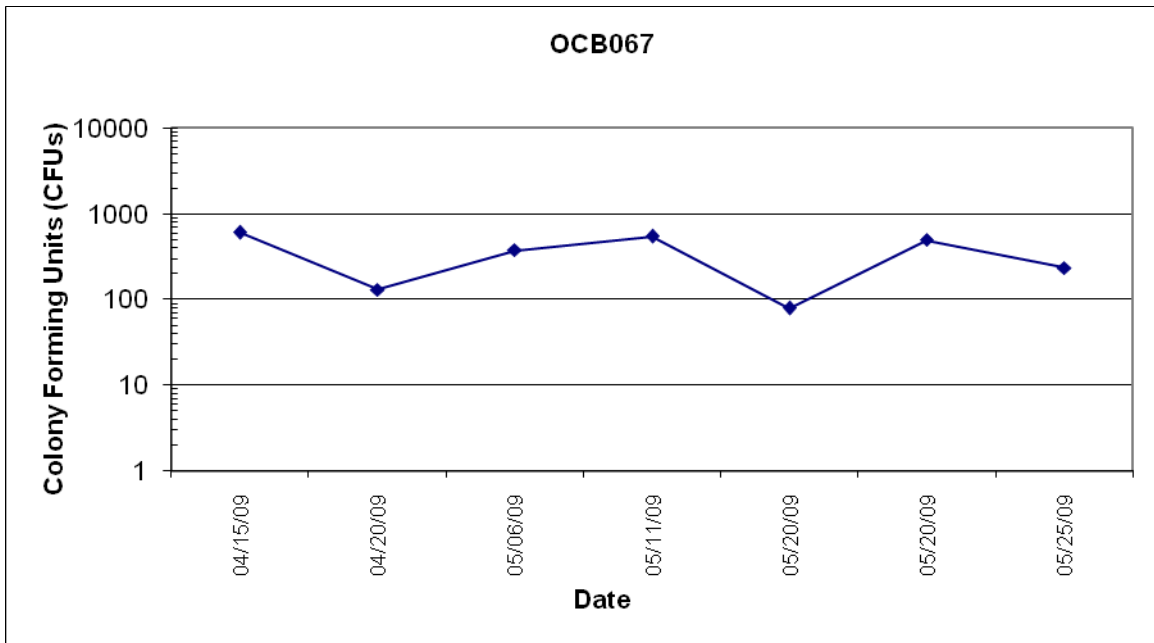
The average *Enterococcus* level was 352 cfu/100mL. The median and mode levels were 375 and 530 cfu/100mL, respectively.

**Figure 29. Summary of Bacteriological Data for OCB067.**

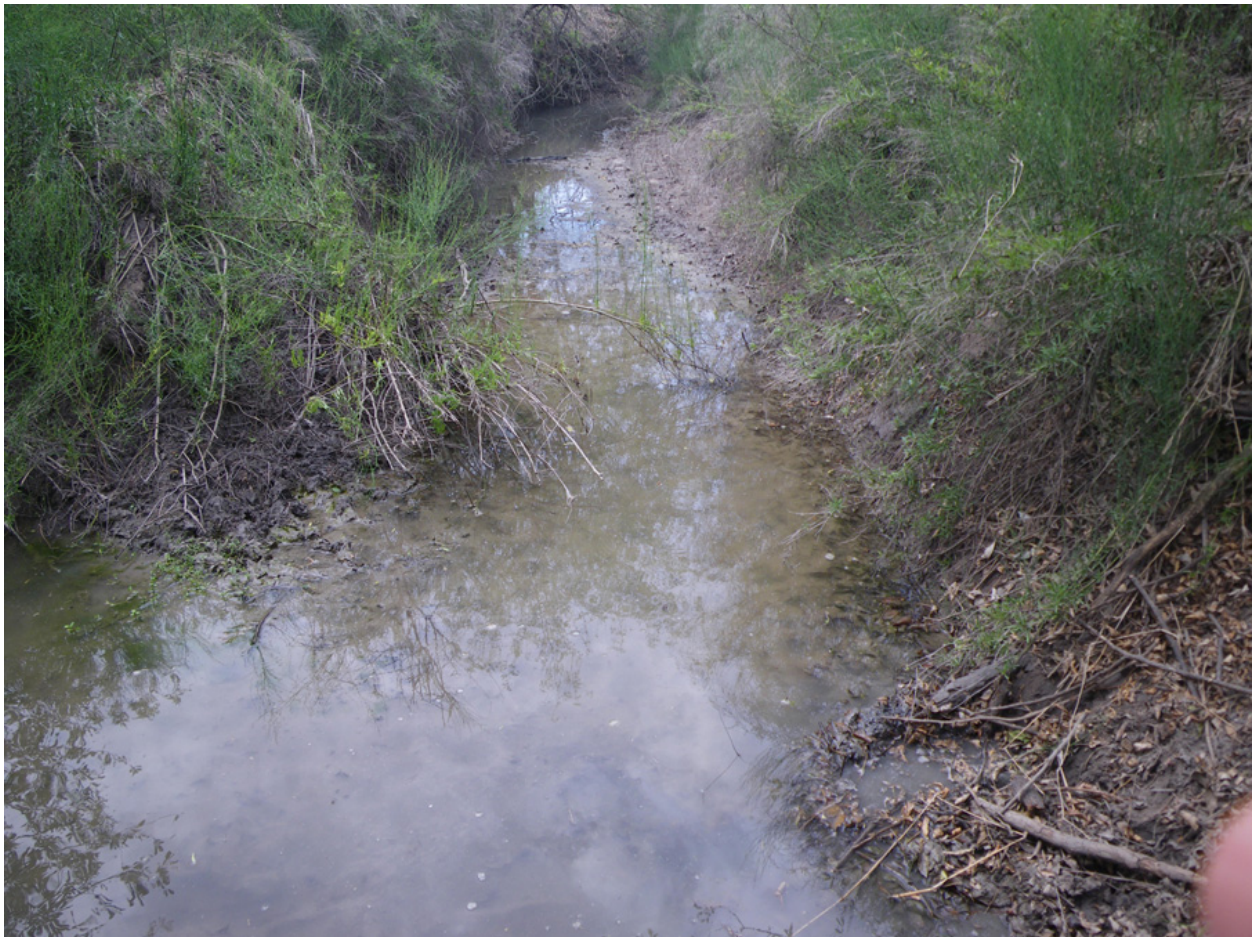
**Figure 30. Photo of OCB 066.**

OCB066 is located approximately 500 m downstream from FM-2292. It is a large ditch that empties into Oso Creek between Old Brownsville Rd and FM-2292. For access reasons the samples were taken from a road that crosses the ditch just upstream from the intersection of the ditch and the creek.

The *Enterococcus* levels at this site ranged from 23 to 3650 cfu/100mL. The average level was 1057 cfu/100mL, and the median was 1020 cfu/100mL. The mode is not applicable for this site, as no values were repeated.
