**A LONG-TERM SEAGRASS MONITORING PROGRAM
FOR CORPUS CHRISTI BAY, UPPER LAGUNA MADRE,
AND BAFFIN BAY**

Final Report

Publication CBBEP – 182
Project Number – 2430

Seagrass Monitoring Project 2430

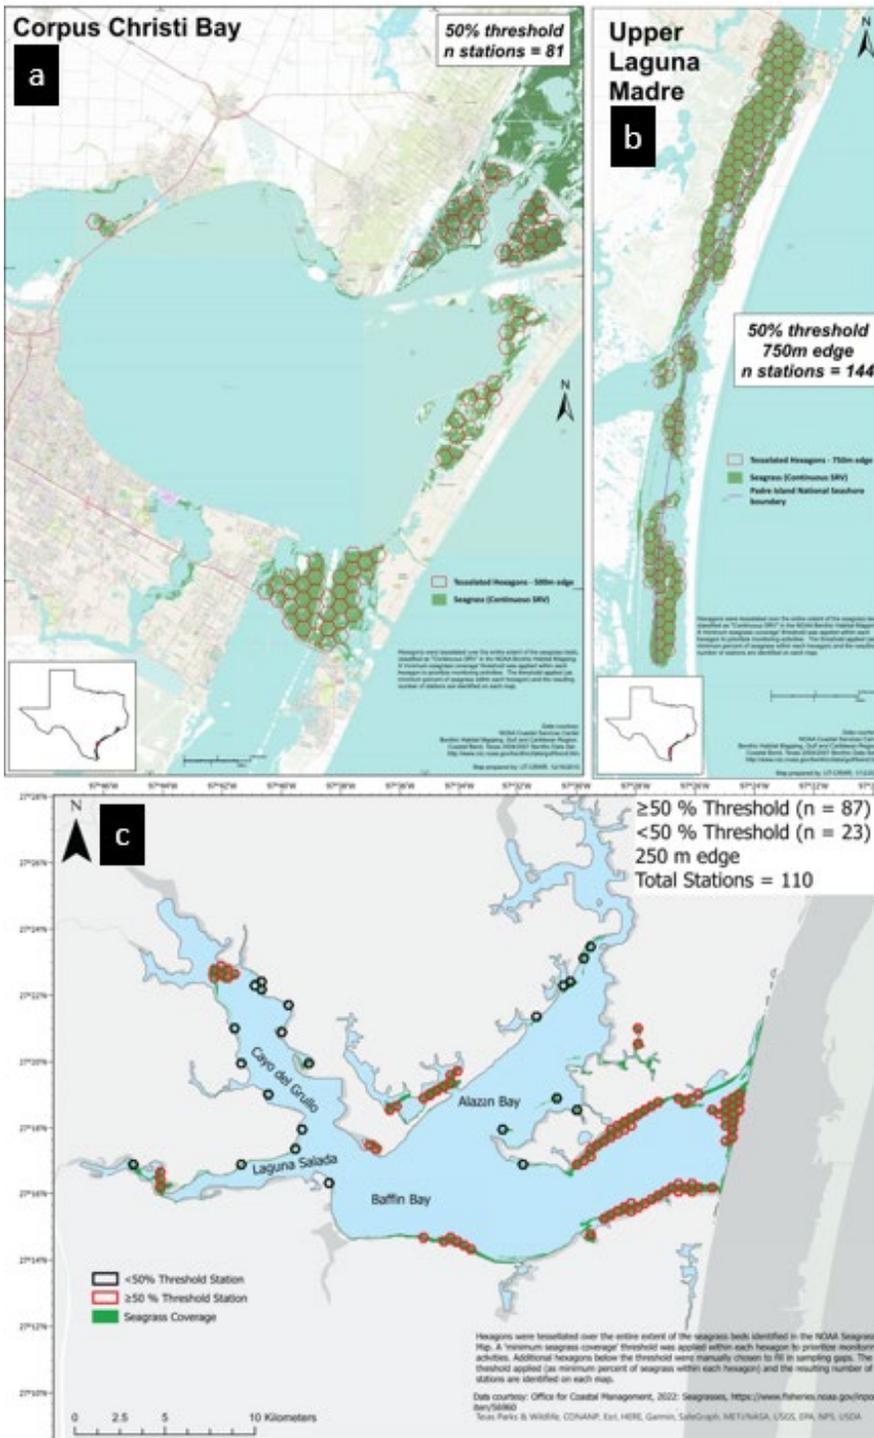
Figure 1. Tessellated boundaries of submerged vegetation delineated during the 2004/2007 NOAA Benthic Habitat Assessment (a, b) or the 2023 NOAA seagrass dataset (c). Resulting stations in a) Upper Laguna Madre (n = 144), b) Corpus Christi Bay (n = 81), or c) Baffin Bay (n = 110) are identified in text on map. Stations outside the National Park Service boundary in Upper Laguna Madre are funded by CBBEP (n = 92) and are delineated by the light purple line on the map. Stations must have >50% seagrass coverage in CCB and ULM, but BB stations in black have less <50%.

This study is part of the Texas seagrass monitoring program, with specific focus on Corpus Christi Bay (CCB), Upper Laguna Madre (ULM), and Baffin Bay (BB) following protocols that evaluate seagrass condition based on landscape-scale dynamics (Figure 1). Secondary bays within each system that have high seagrass coverage were also included (e.g., Nueces Bay, Alazan Bay). The program is based on a hierarchical strategy for seagrass monitoring outlined by Neckles et al. (2012) to establish the quantitative relationships between physical and biotic parameters that ultimately control seagrass condition, distribution, persistence, and overall health. This approach follows a broad template adopted by several federal and state agencies across the country but is uniquely designed for Texas (Dunton et al., 2011) and integrates plant condition indicators with landscape feature indicators to detect and interpret seagrass bed disturbances.

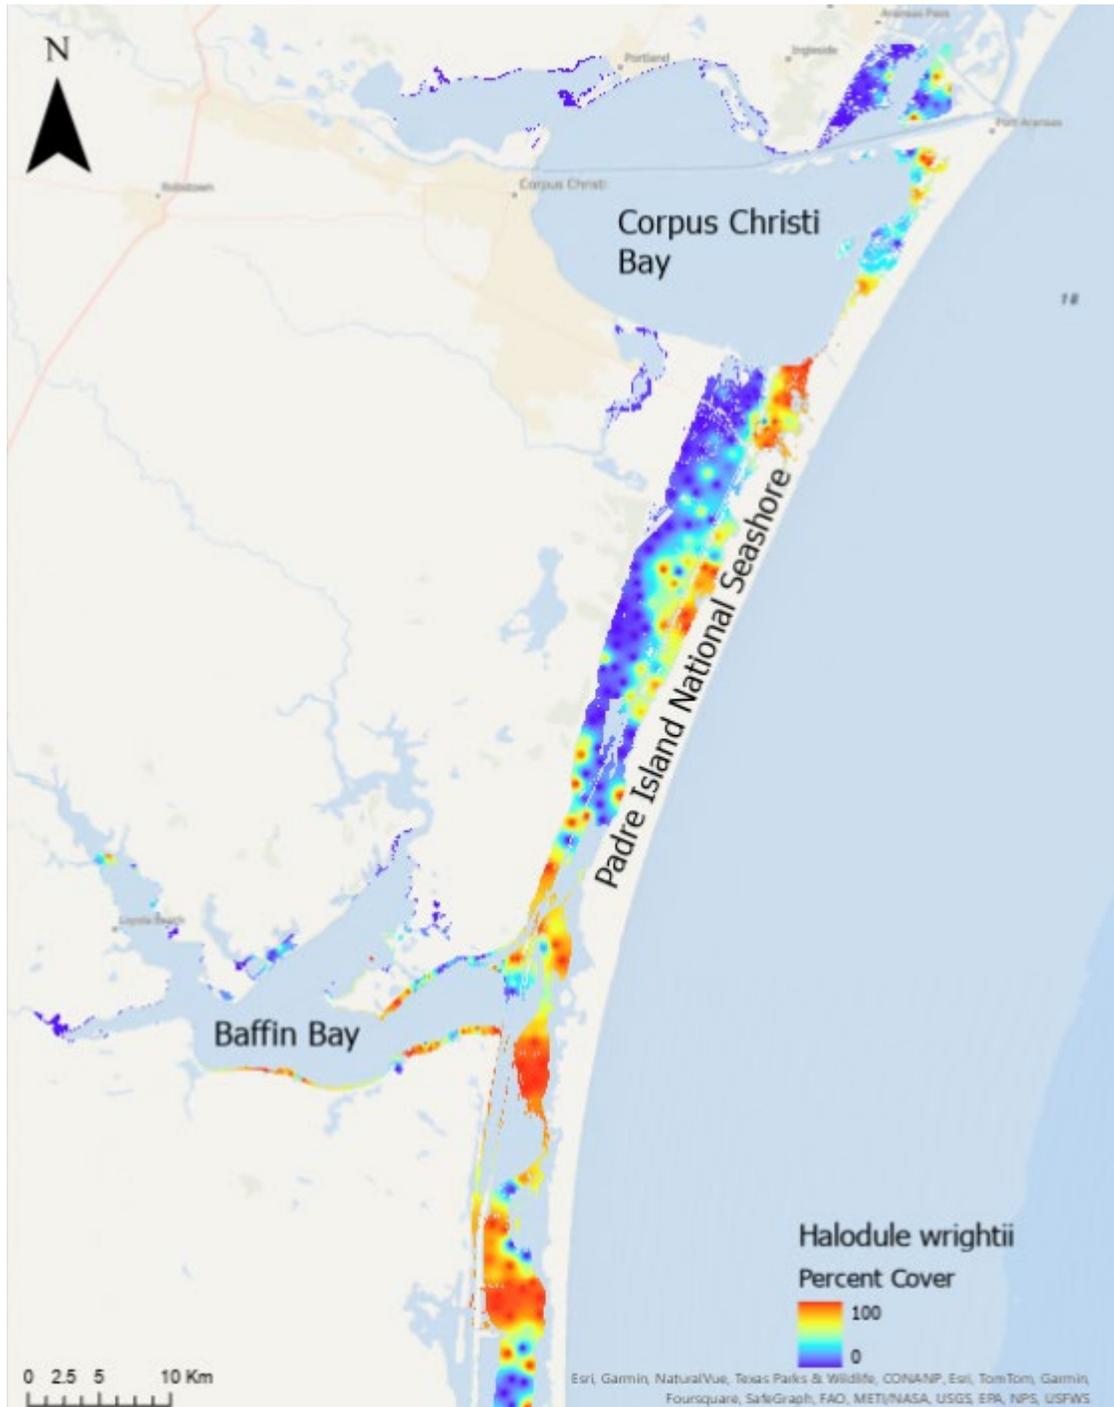
Figure 2. Spatial representations of percent cover for *Halodule wrightii* for 2023. The spatial data interpolation is limited to the boundaries of seagrass habitat delineated by the 2023 NOAA USA seagrass distribution database.

The mean seagrass coverage for sites sampled in the CCB region was 62.3%. The seagrass assemblage (Table 3) in CCB was dominated by *Halodule wrightii* ($38 \pm 40.8\%$; Figure 2), followed by *Thalassia testudinum* ($16.5 \pm 30\%$; Figure 3) and *Syringodium filiforme* ($7.7 \pm 20\%$; Figure 4), with minor contributions from *Halophila engelmannii* ($0.1 \pm 0.4\%$; Figure 6) and *Ruppia maritima* ($0 \pm 0.1\%$; Figure 5). *Halodule wrightii* was most widely distributed within the CCB region relative to the other seagrass species (Figure 2). However, minimal cover was observed in the southwest portion of Redfish Bay, which was dominated by *Thalassia testudinum*. Four stations ($\sim 5\%$) in the CCB did not have vegetation present. Low seagrass cover was observed in southern Redfish Bay near Ingleside and Aransas Pass, and northwest of the JFK causeway (Figure 7). Overall, *Thalassia testudinum* and *Halodule wrightii* coverage in the CCB remained stable between 2021 and 2022 (Capistrant-Fossa & Dunton, 2023), while *Syringodium filiforme* coverage increased by $\sim 6\%$. Canopy height (Table 4) was greatest in *Thalassia testudinum* (19.9 ± 4.3 cm), followed by *Syringodium filiforme* (18.2 ± 7.5 cm), *Halodule wrightii* (15 ± 4.3 cm), *Ruppia maritima* (6.1 ± 2.5 cm) and *Halophila engelmannii* (3.3 ± 2.4 cm).

The mean seagrass cover for all species was 55.5%, the highest coverage since 2021 because of *Syringodium filiforme* (2.8%) gains. However, the coverage of the dominant seagrass, *Halodule wrightii*, decreased (-1.4% ; Table 3; Figure 2). *Ruppia maritima* was not found in Nine Mile Hole, whereas it was present in ULM in 2022 (Figure 3, Capistrant-Fossa et al., 2023). No *Thalassia testudinum* was present during sampling. Thirty-five sampling stations in 2023 and 2022 (24%) were devoid of vegetation compared to only twenty-five sampling stations in 2021. Typically, stations that were bare or had low seagrass cover corresponded with greater water depths (>1.5 m) especially those located along the northwestern shore of Laguna Madre (Figure 4). Seagrass coverage was also low in Nine Mile Hole where some sites had substantial amounts of drift wrack (i.e., mats of dead seagrass). *Syringodium filiforme* has maintained high cover near the JFK Causeway and the mouth of Baffin Bay (Figure 5). *Halophila* was rarely found in northern ULM and Nine Mile Hole (Figure 6). Little rooted wrack (dead seagrass) or attached macroalgae was found in ULM (Figures 7, 8). The highest canopy height values were observed in *Syringodium filiforme* (20.7 ± 5.8 cm; Table 4), followed by *Halodule wrightii* (16.8 ± 7.8 cm), and *Halophila engelmannii* (2.0 ± 0.2 cm). Mean canopy height was significantly lower in 2023 than 2022 and 2021 (Capistrant-Fossa et al., 2023).

The mean seagrass cover for sites in Baffin Bay was 44.8% for all species. The seagrass percent cover was 14.6% higher than in 2022 due to the increase of *Halodule wrightii* (14.7%, Capistrant-Fossa et al., 2023). Overall, BB was mainly composed of *Halodule wrightii* ($43.4 \pm 42.1\%$; Table 3, Figure 2) with the highest abundance located on the mouth of the bay, along the southwest and northwest shore near Upper Laguna Madre. Furthermore, a small patch on the northern section of Cayo del Grullo gained more percent cover compared to 2022 (Capistrant-Fossa et al., 2023). Other species like *Syringodium filiforme* ($0.6 \pm 5.4\%$; Table 3, Figure 4), *Ruppia maritima* ($0.1 \pm 1.3\%$; Table 3, Figure 5), and *Halophila engelmannii* ($0.7 \pm 4.5\%$; Table 3, Figure 6) had minor contributions with small patches in different regions of the system. *Syringodium filiforme* and *Ruppia maritima* had a decrease of 0.1% and 0.6% respectively, although patches of these species were found in the same stations as in 2022 (e.g. *S. filiforme* in the mouth of bay, and *R. maritima* in Cayo del Grullo). *Halophila engelmannii* was located on the mouth of the bay near Upper Laguna Madre, with an increase of 0.6%. *Thalassia testudinum* was not found in any of the stations. Additionally, seagrass was not found in twenty-nine stations (32.9%) located near Laguna Salada, Alazan Bay, and Cayo del Grullo (Figure 7). These regions coincide with the bare patches reported in 2022. Canopy height was highest in *Halodule wrightii* with a mean of 17.2 ± 6.6 cm (Table 4), followed by *Syringodium filiforme* with a mean of 13.7 ± 2.7 cm (Table 4), *Halophila engelmannii* (6.6 ± 1.5 cm; Table 4), and *Ruppia maritima* (3.6 ± 1.7 cm; Table 4).

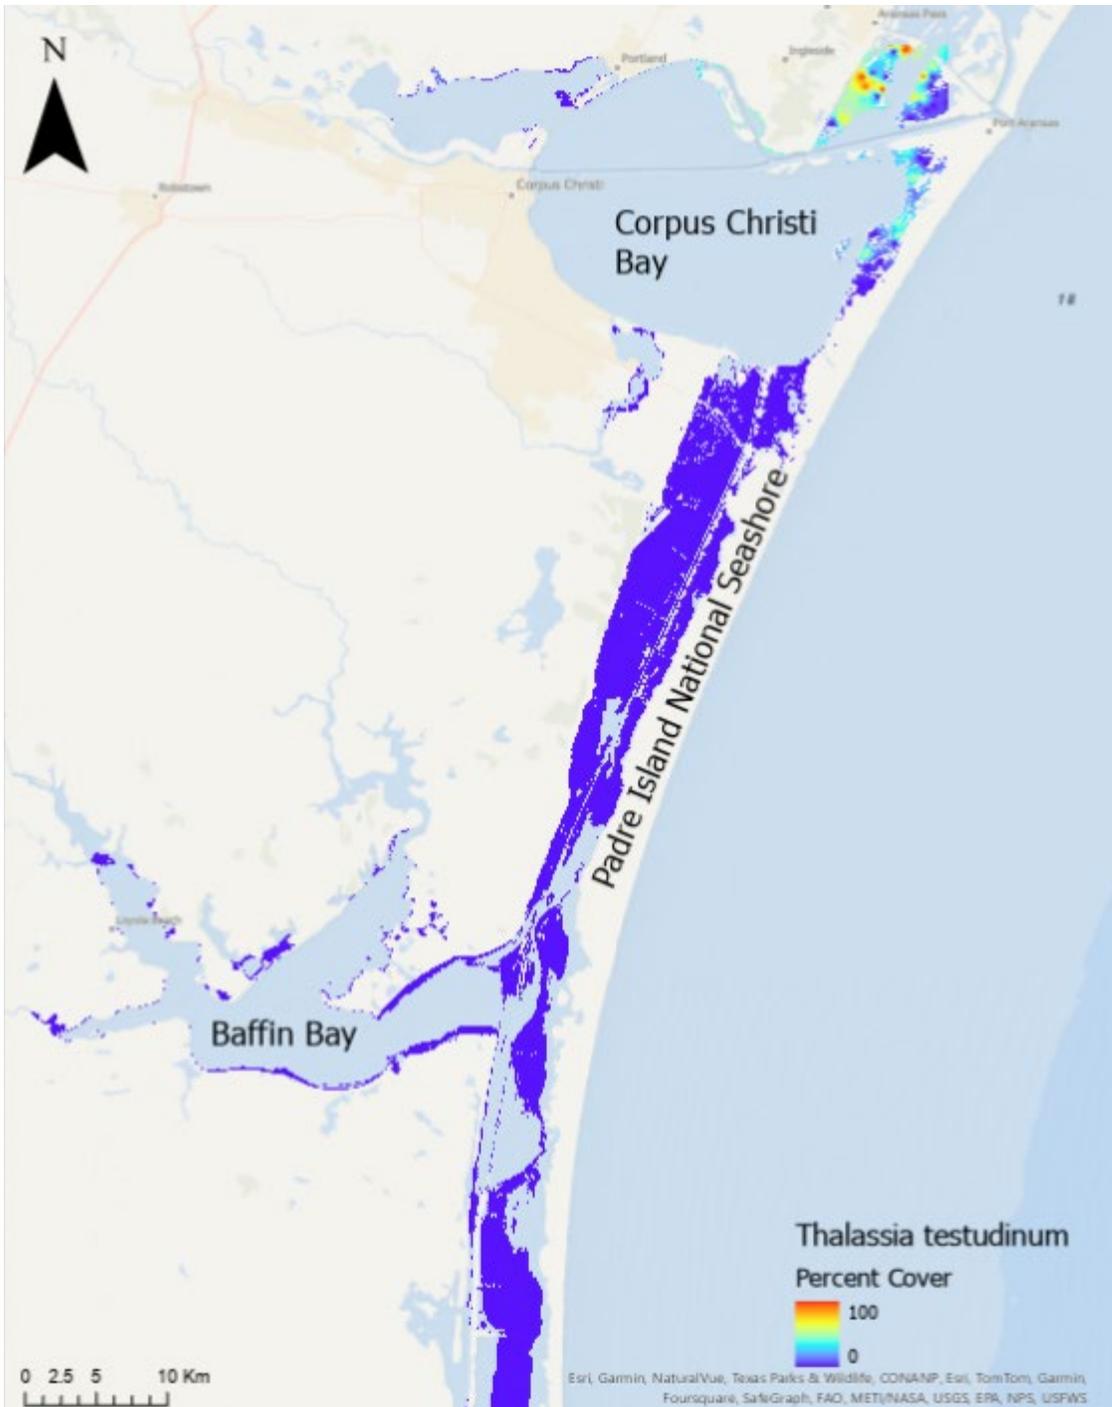
Figure 3. Spatial representations of percent cover for *Thalassia testudinum* for 2023. The spatial data interpolation is limited to the boundaries of seagrass habitat delineated by the 2023 NOAA USA seagrass distribution database.

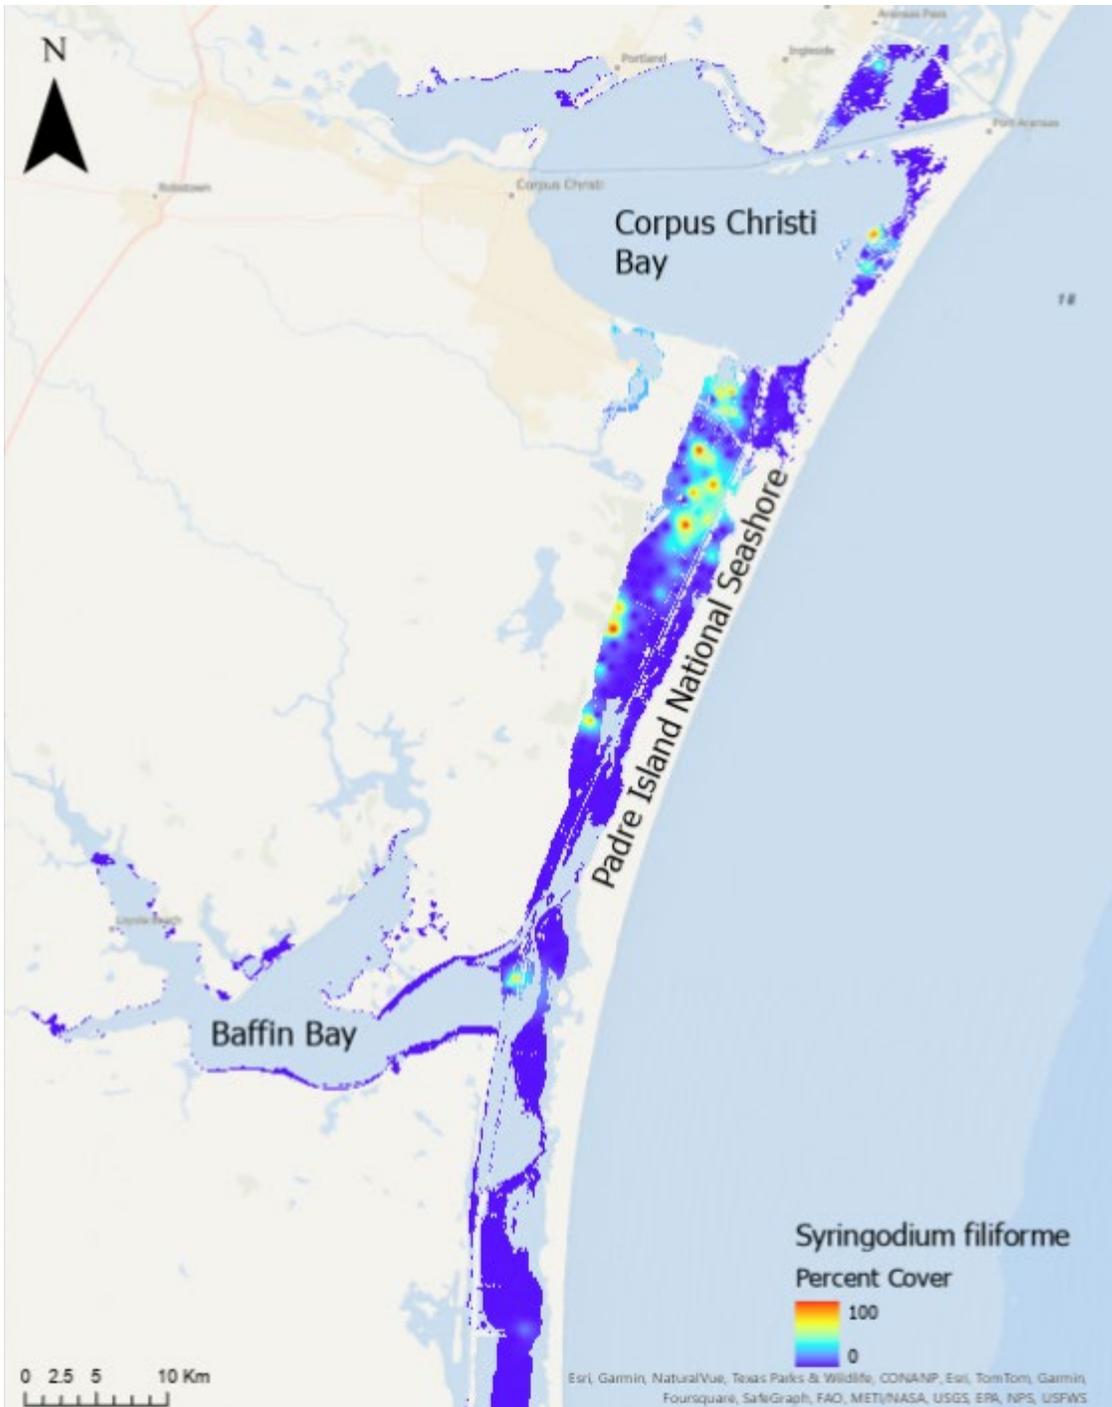
Figure 4. Spatial representations of percent cover for *Syringodium filiforme* for 2023. The spatial data interpolation is limited to the boundaries of seagrass habitat delineated by the 2023 NOAA USA seagrass distribution database.

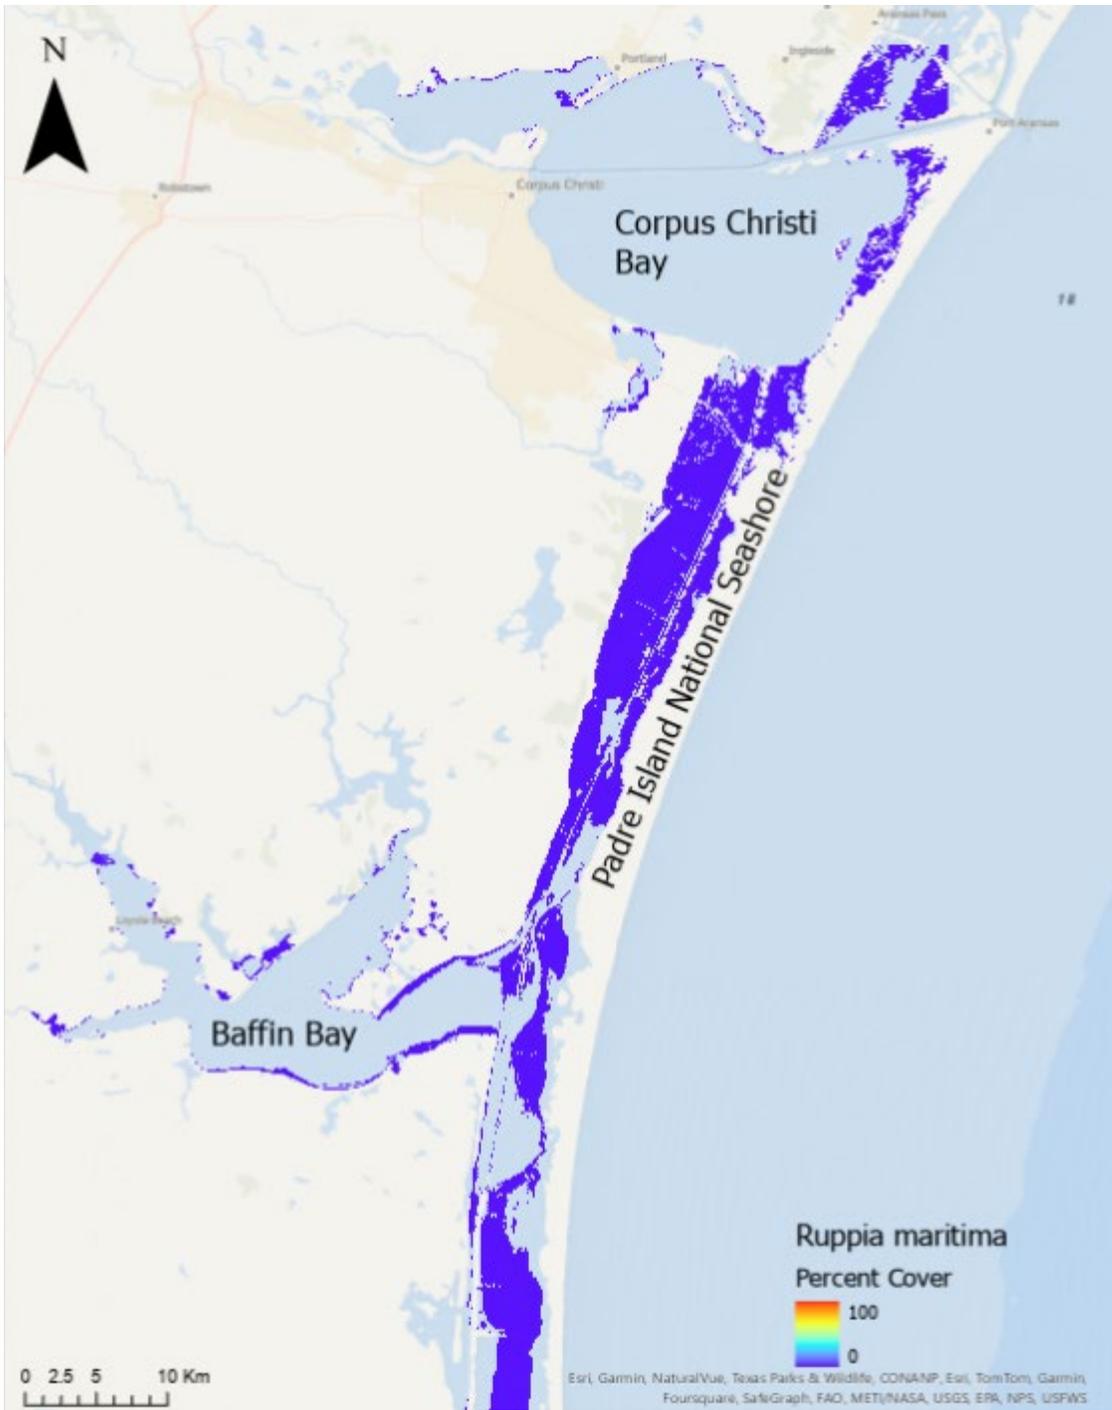
Figure 5. Spatial representations of percent cover for *Ruppia maritima* for 2023. The spatial data interpolation is limited to the boundaries of seagrass habitat delineated by the 2023 NOAA USA seagrass distribution database.

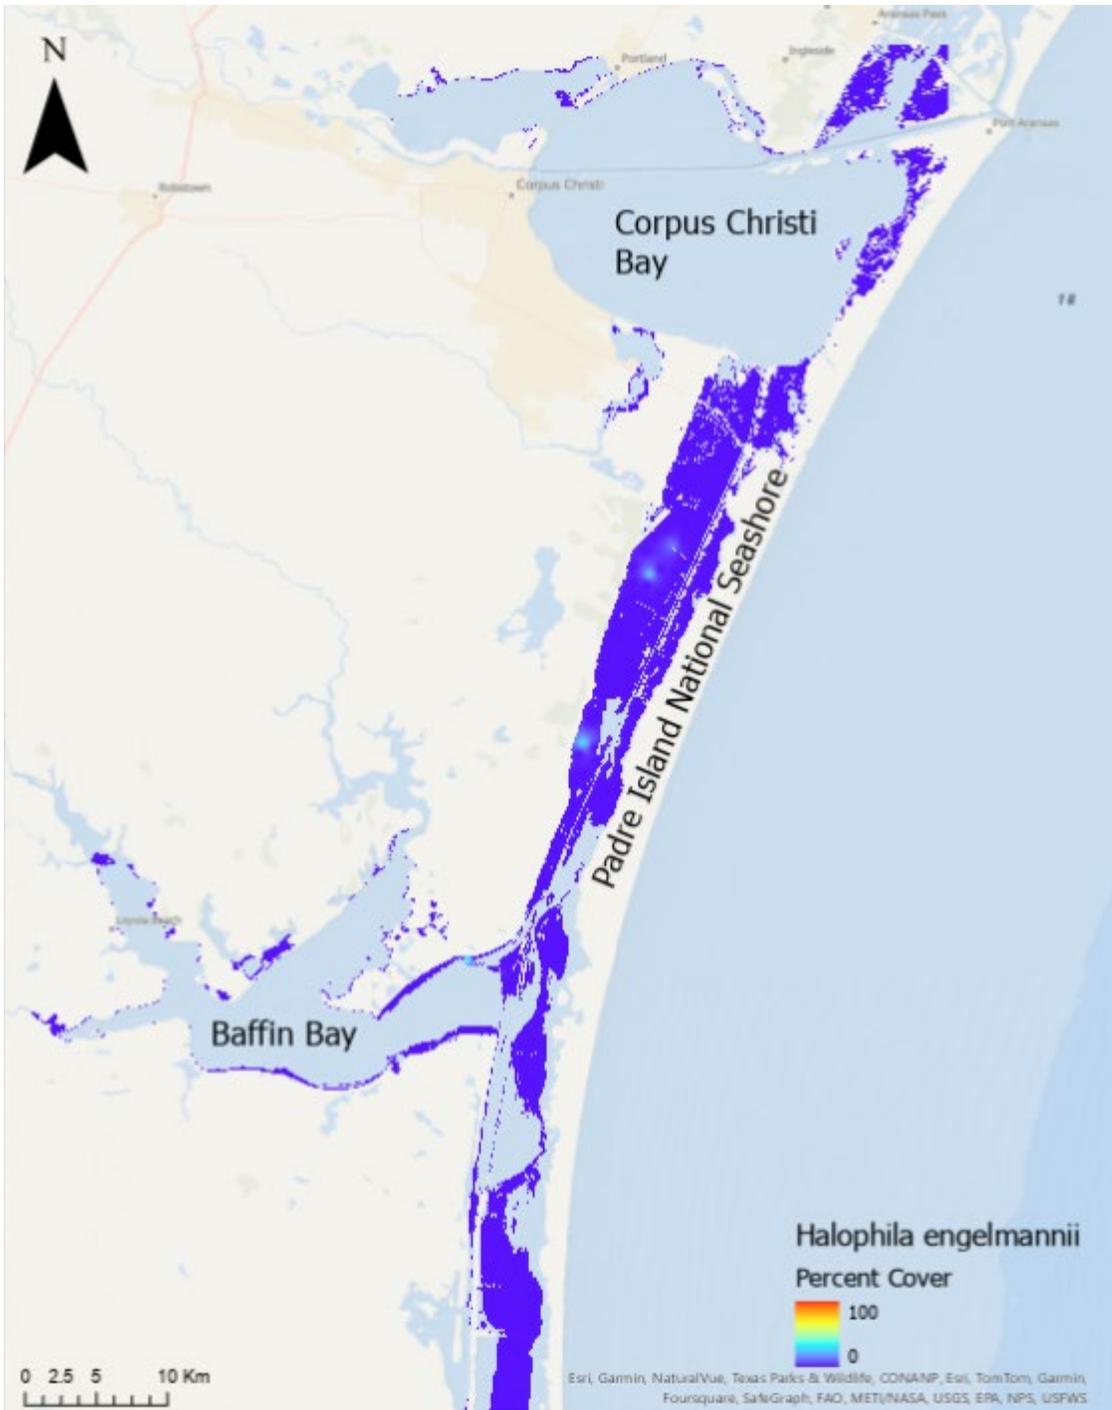
Figure 6. Spatial representations of percent cover for *Halophila engelmannii* for 2023. The spatial data interpolation is limited to the boundaries of seagrass habitat delineated by the 2023 NOAA USA seagrass distribution database.

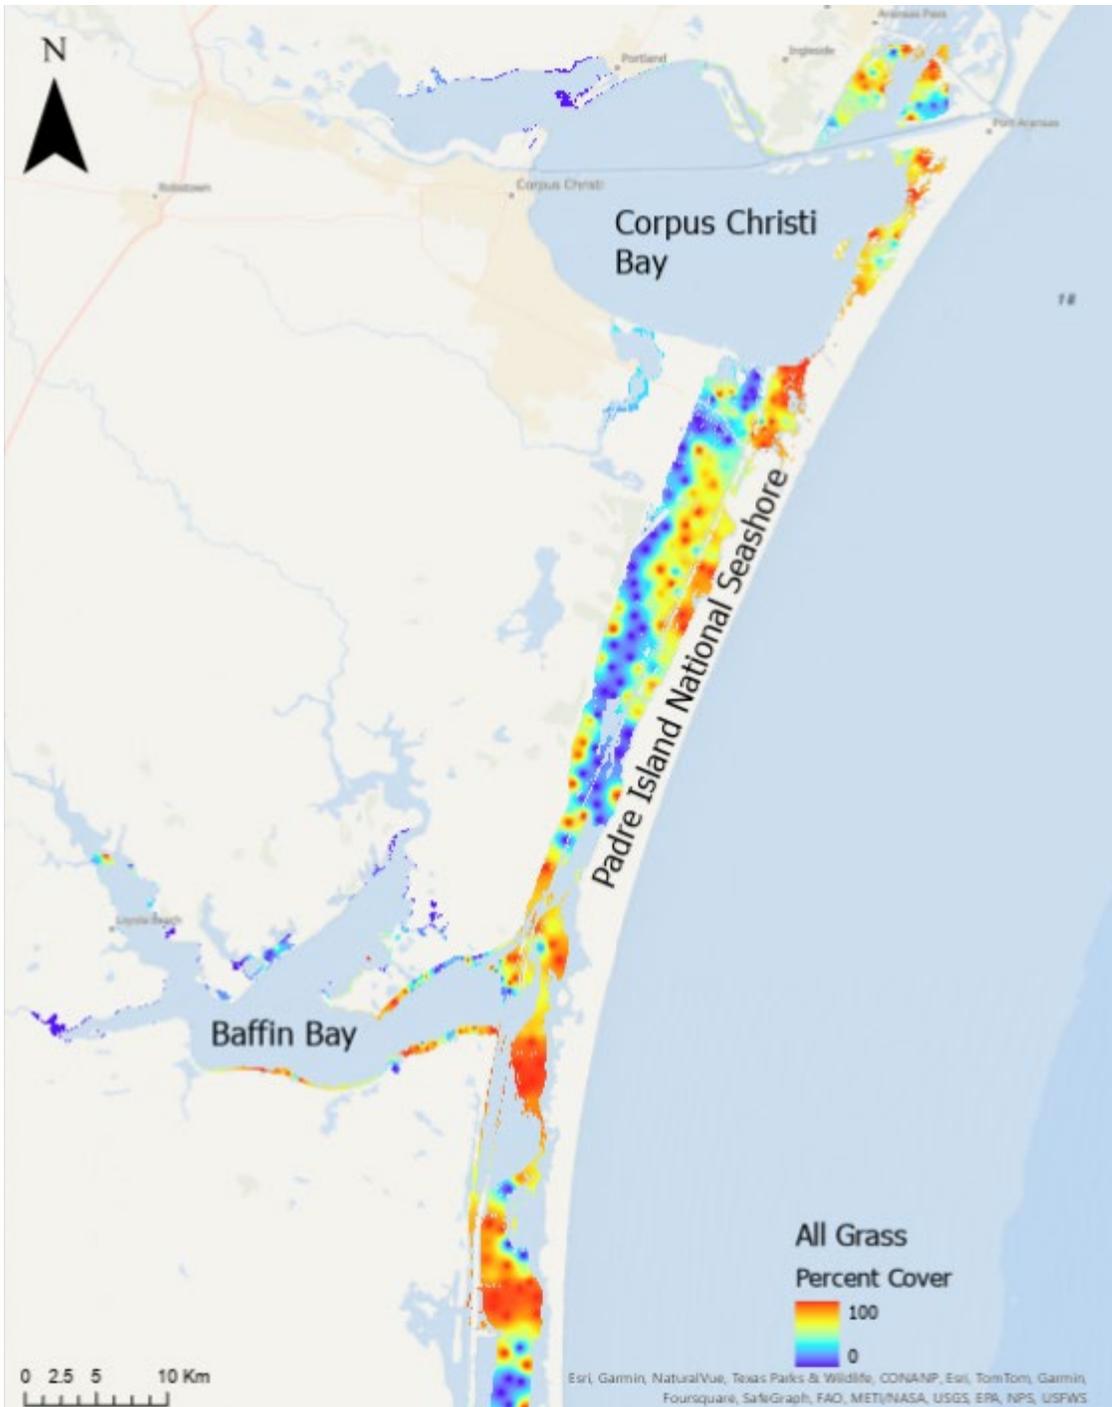
Figure 7. Spatial representations of percent cover for all seagrass species for 2023. The spatial data interpolation is limited to the boundaries of seagrass habitat delineated by the 2023 NOAA USA seagrass distribution database.

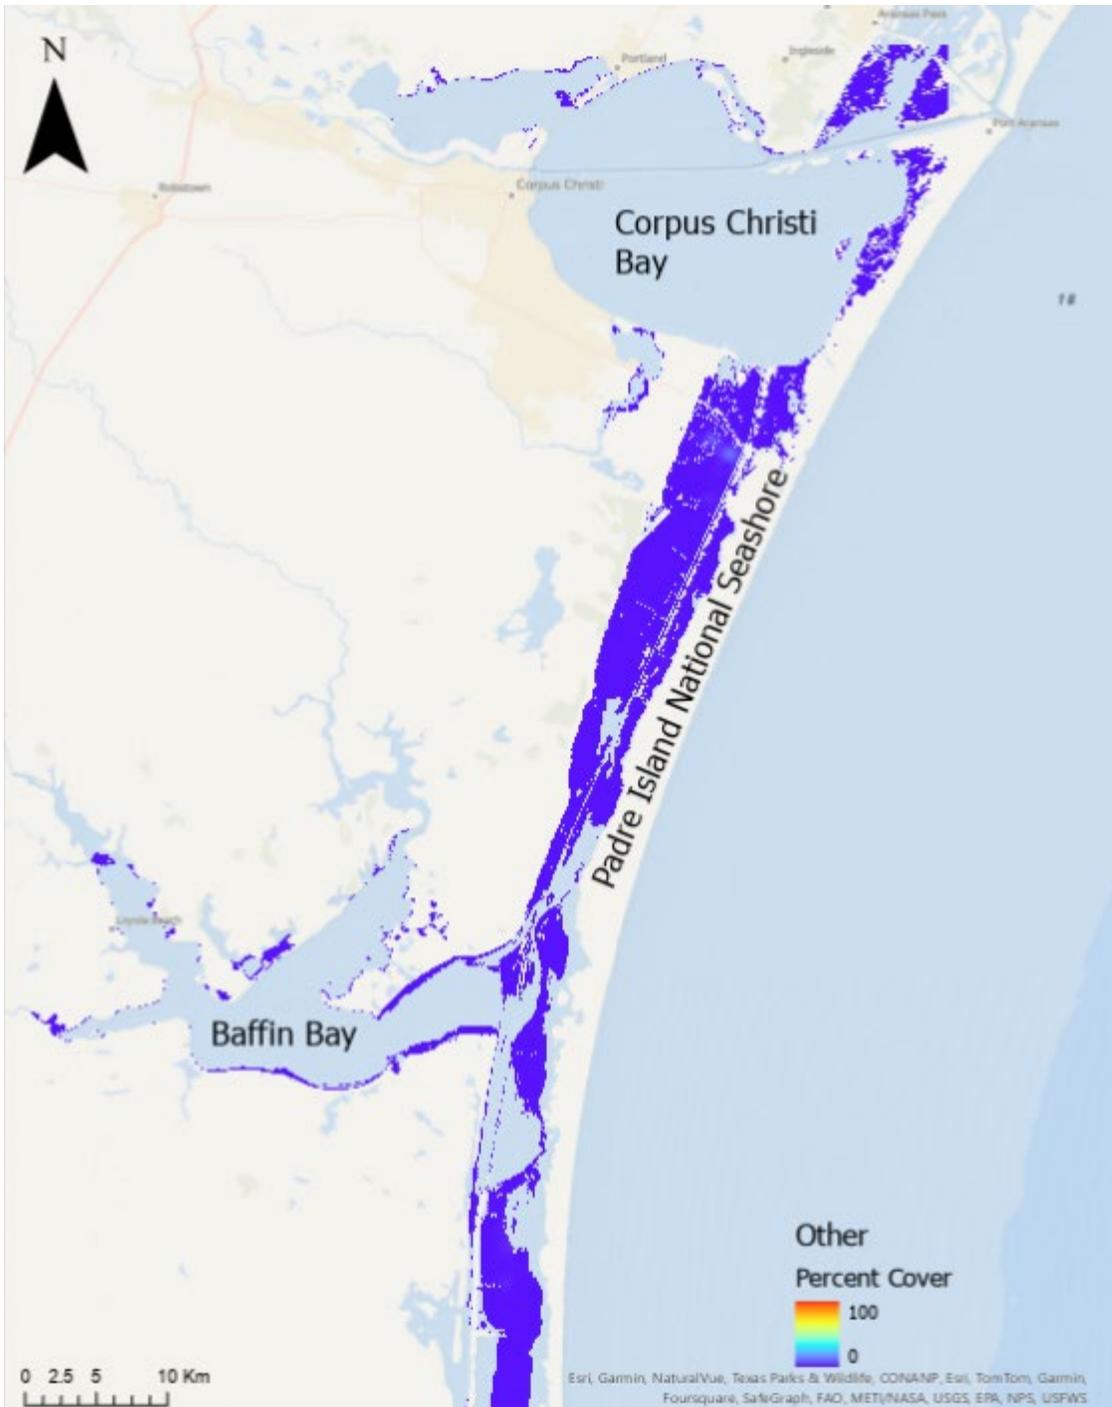
Figure 8. Spatial representations of percent cover for living, non-seagrass, ecosystem components (e.g., macroalgae) for 2023. The spatial data interpolation is limited to the boundaries of seagrass habitat delineated by the 2023 NOAA USA seagrass distribution database.

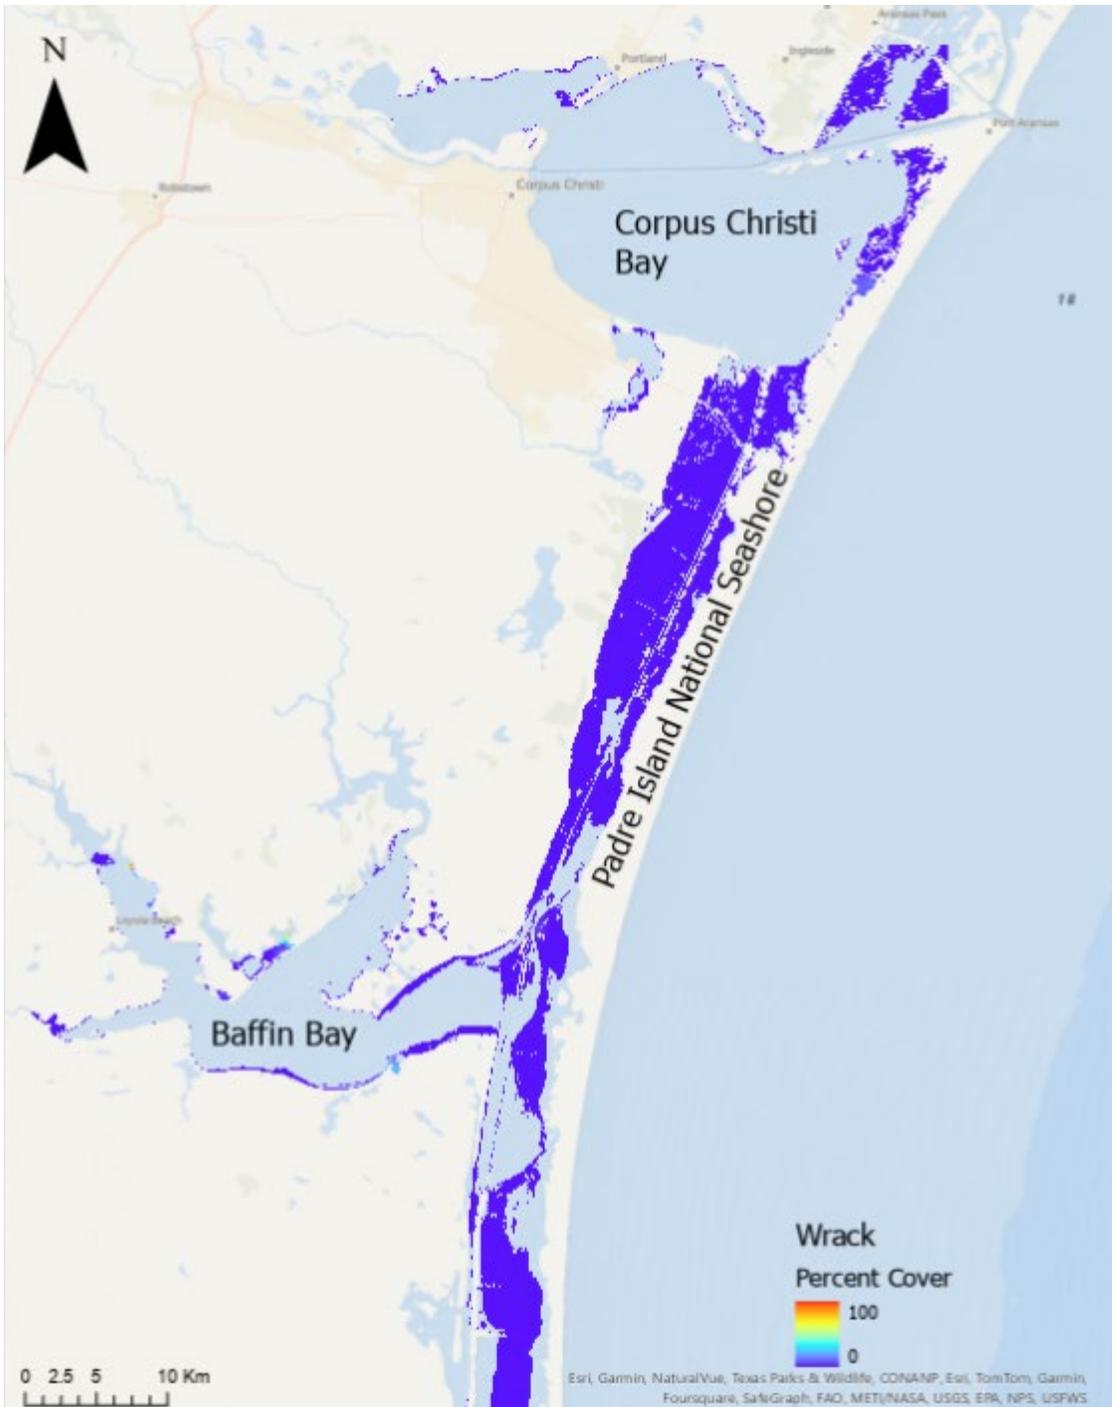
Figure 9. Spatial representations of percent cover for seagrass wrack for 2023. The spatial data interpolation is limited to the boundaries of seagrass habitat delineated by the 2023 NOAA USA seagrass distribution database.
