January 2025

## Restoration of the Nueces Delta

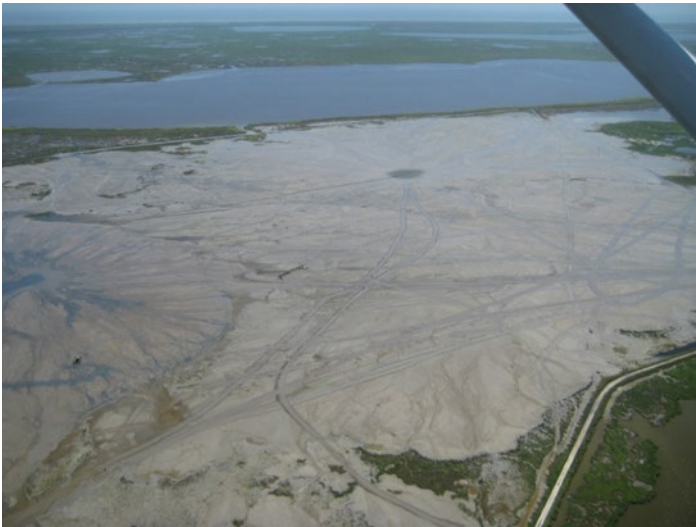
To see a good example of how successful these types of projects can be, we just have to look up the coast a bit to Texas Parks and Wildlife Department's JD Murphee Wildlife Management Area. At the WMA located near Port Arthur, Ducks Unlimited partnered with TPWD to beneficially use dredged sediment to rebuild lost habitat, restoring 1,500 acres of marsh that had been battered by a busy hurricane season. The difference of the landscape just days after the sediment was placed compared to several years later is incredible, with native vegetation and wildlife returning to the area and public recreation growing along with them.

Left Photo - JD Murphee WMA in 2010, immediately following placement of dredge material (photo credit Ducks Unlimited)

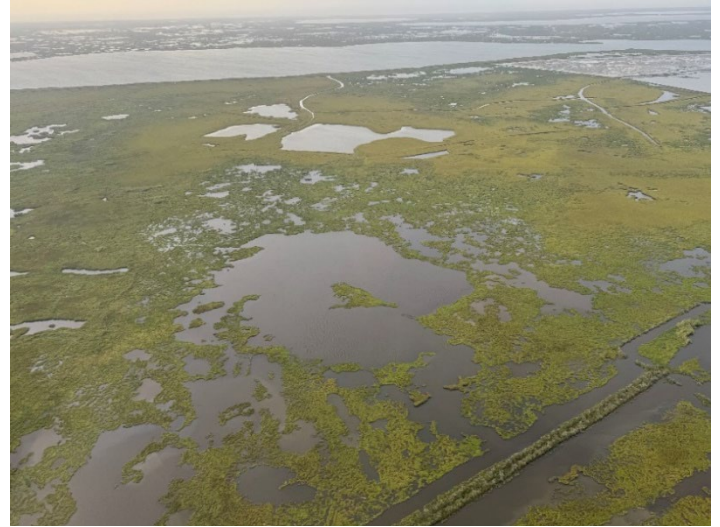
Right Photo - JD Murphee WMA in 2024, 14 years following placement of dredge material (photo credit Ducks Unlimited)
